Technical Service Bulletin

01 MIL on (P1545, P0121, P0123, P0221 or P0222 stored in ECM)

01 14 96 2018260/8 September 26, 2014. Supersedes Technical Service Bulletin Group 01 number 13-76 dated March 14, 2013 for reasons listed below.

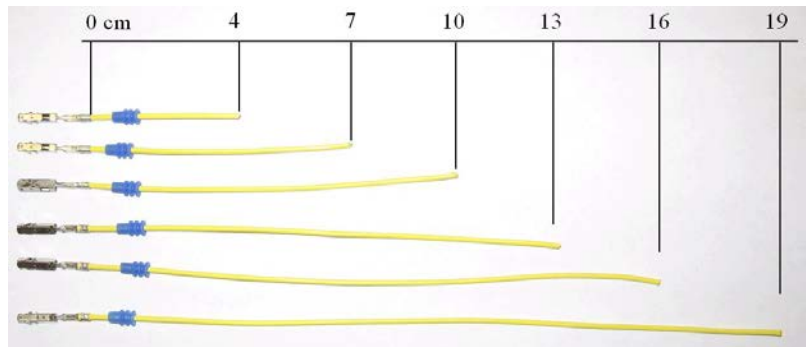
Figure 1. Correctly preassembled wires and seals.

3. Lengthen wires and preassemble seals as shown (Figure 1).

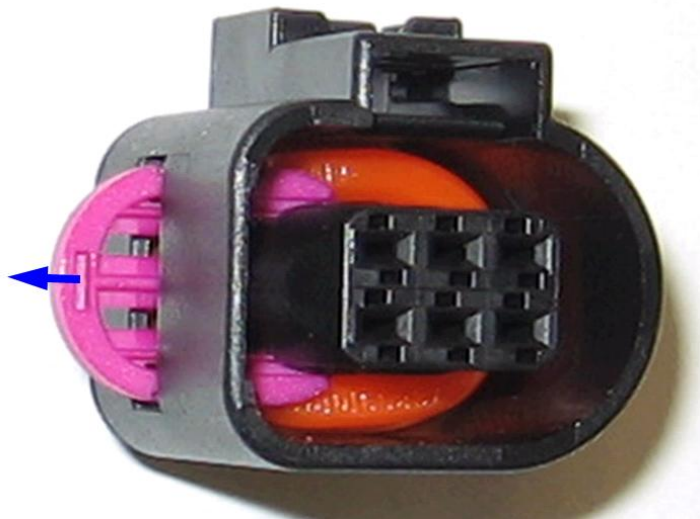
Figure 2. The slot to be used to remove the pink lock.

4. On the new housing, remove pink lock with small flathead screwdriver, using the slot on the pink lock (Figure 2).

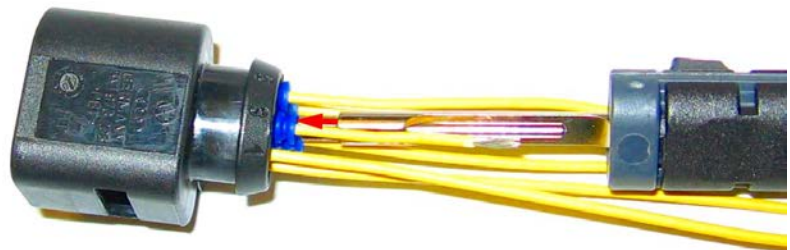
Figure 3. The single wire seal, slid as far as the stop.

5. Insert all terminals into housing until they audibly click.
6. Reinstall pink lock.
7. Using the appropriate assembly tool, slide the single wire seal up the repair wire until it contacts the housing. Continue to slide the single wire seal into the housing as far as the stop (Figure 3).
