Technical Service Bulletin

91 Parking assistance provides false warnings

91 14 72 2024323/4 December 19, 2014. Supersedes Technical Service Bulletin Group 91 number 13-74 dated February 5, 2013 for reasons listed below.

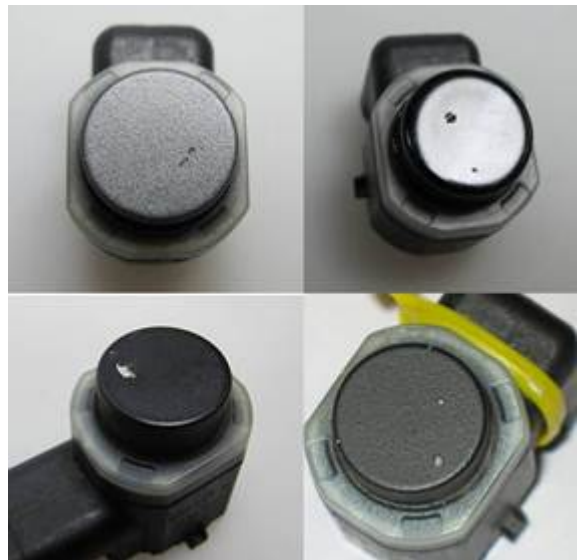
3. Check parking sensors (Figure 1) for obvious issues:
 - Mechanical damage (stone chips, scratches).
 - Dirt, ice, foreign bodies, foil adhered to sensor.
 - Damage to the bumpers that may indicate an accident (or paint indicating a previous incident).

Figure 1. Stone chips causing sensor failure.

Tip: Exterior damage to the vehicle, including stone chips and scratches, is not covered by Audi Warranty. When painting sensors, the special painting instructions for parking sensors in the paint repair manual must be observed.

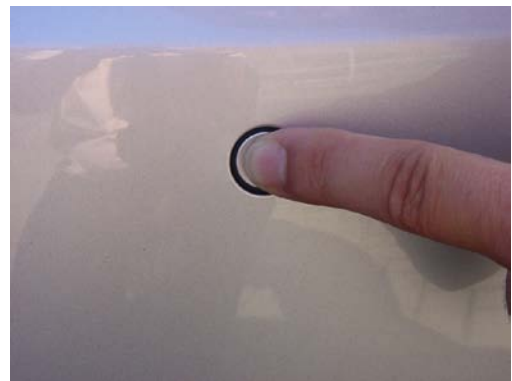
- Aftermarket lowering kit.
 - Aftermarket spoiler or air deflector.
 - Aftermarket bumper.
5. For 8-channel systems, check the installation of the front license plate holder for:
- Protrusion. The license plate and holder must fit on flat.
 - Bent corners. Any bent-open corners may cause false readings.
 - Correct fit. Oversized license plate holders or frames can obstruct parking aid sensors.
6. Pressure check for a tight fit and correct attachment of the parking sensors (Figure 2). If the sensor is not snug or feels loose, remove the bumper and reinstall the sensor.

Figure 2. A pressure check on a parking aid sensor.

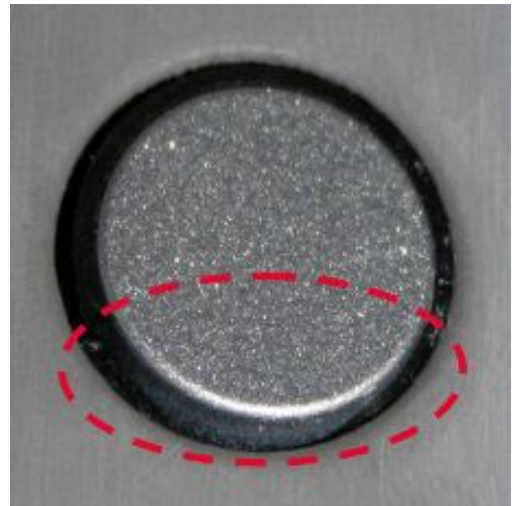
Figure 4. An incorrectly seated decoupling ring (bulging).

7. Check that the decoupling ring is correctly seated (Figure 3, Figure 4, Figure 5). If the ring is folded or bulging, remove the bumper and reinstall the sensor.

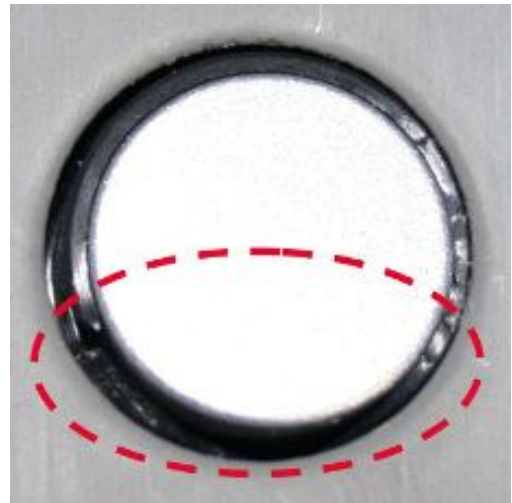
Figure 5. An incorrectly seated decoupling ring (folded).

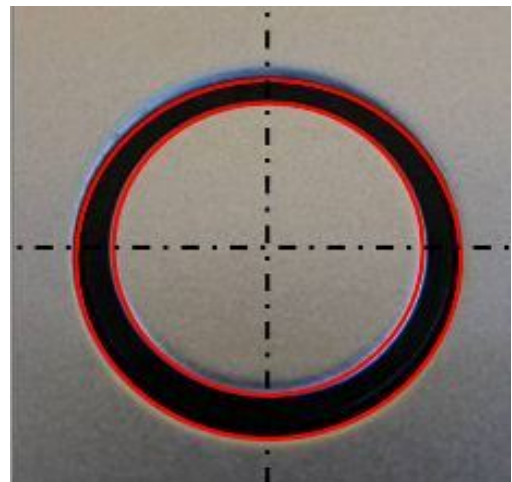
Figure 7. An off-center parking aid sensor.

8. Verify that the sensor is centered inside of the mounting hole (Figure 6, Figure 7). If the sensor is mounted off-center, remove the bumper and reinstall the sensor.

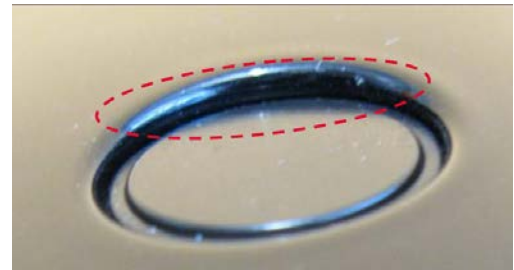
Figure 9. A recessed parking aid sensor.

9. Ensure the sensor sits flush with the bumper (Figure 8, Figure 9). If the sensor is recessed or bulging, remove the bumper and reinstall the sensor.

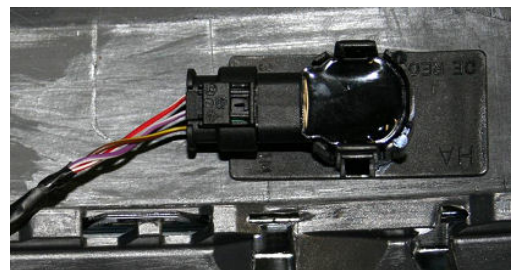
Figure 11. A sensor cable with insufficient length.

12. Check the cables in the bumper for damage and sufficient length (Figure 10, Figure 11). Cables that are too short can cause damage to the harness.
 - If the cable is damaged, repair the cable using VAS Repair Kit 1978.
 - If the cable is too tight, correct the routing by moving the support clip so the cable is no longer under tension.

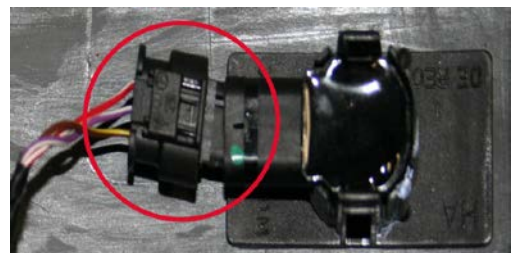
Figure 13. A parking aid sensor connector that is not seated correctly.

13. Check the connectors on the parking sensors and the socket box for correct installation (Figure 12, Figure 13). If the connectors are not installed properly, reinstall.
