Technical Service Bulletin

96 Warning message in DIS: "Key not In vehicle" or "Remote key not recognized"

96 14 90 2039108/2 December 5, 2014. Supersedes Technical Service Bulletin Group 96 number 14-89 dated December 3, 2014 for reasons listed below.

Model(s)	Year	VIN Range	Vehicle-Specific Equipment
Q3	2015	All	Not Applicable

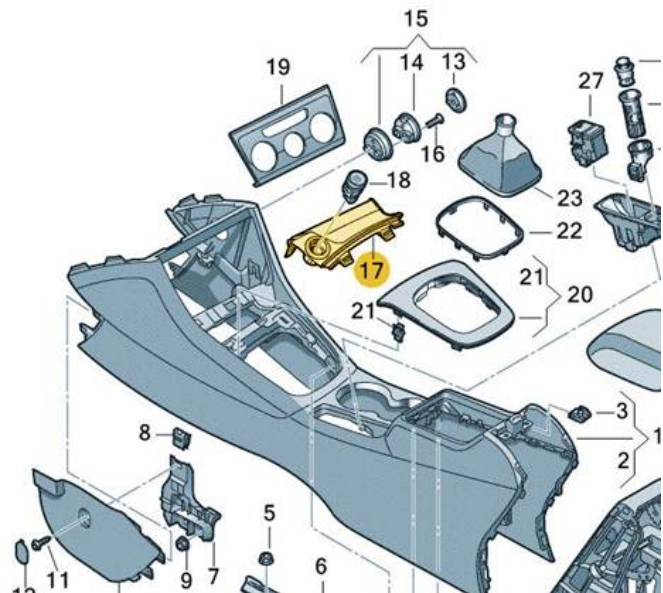
Figure 1. The front storage compartment in the center console (Number 17).

1. Remove the front storage compartment according to the Elsa Repair Manual (Figure 1).

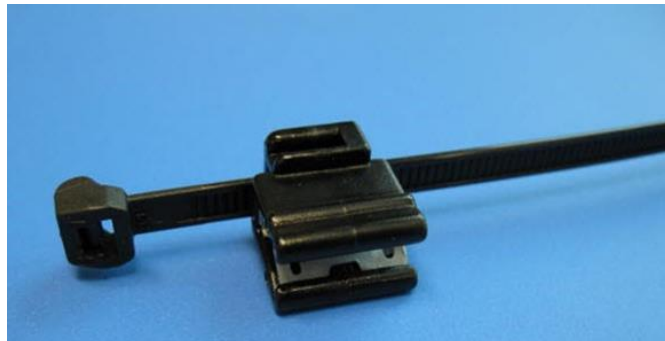
Figure 2. Zip tie with holder.

5. Using a zip tie with holder (**3D0 971 838 M**) (Figure 2), turn the zip tie by 90° (Figure 3).

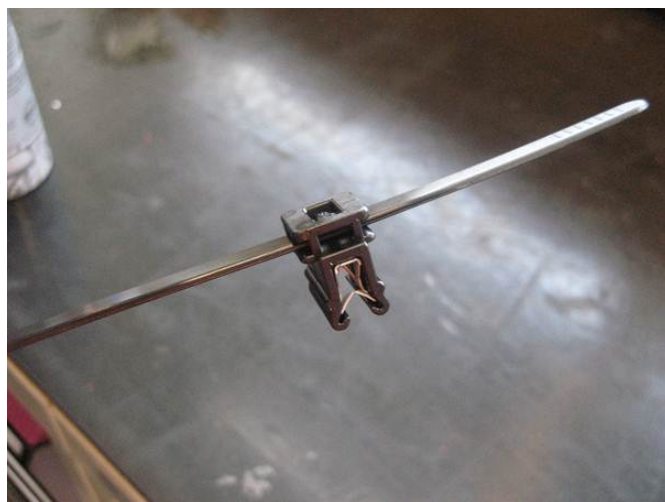
Figure 3. Zip tie turned by 90°.

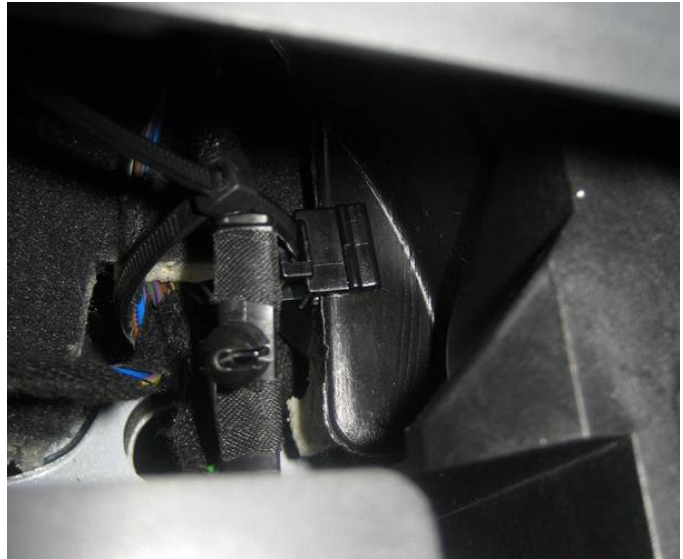
Figure 4. The zip tie with holder is installed but not tightened.

6. Attach the zip tie with holder as shown (Figure 4). Do not tighten the zip tie.

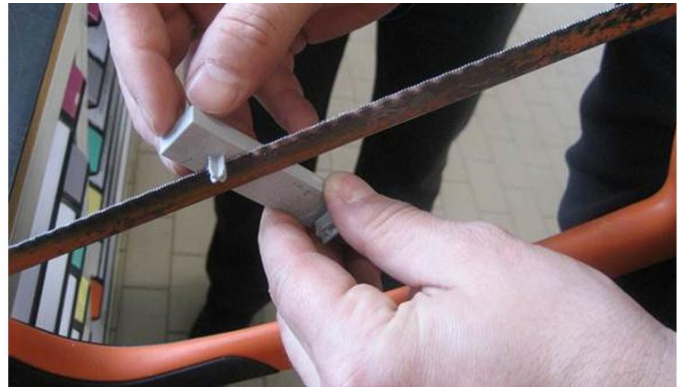
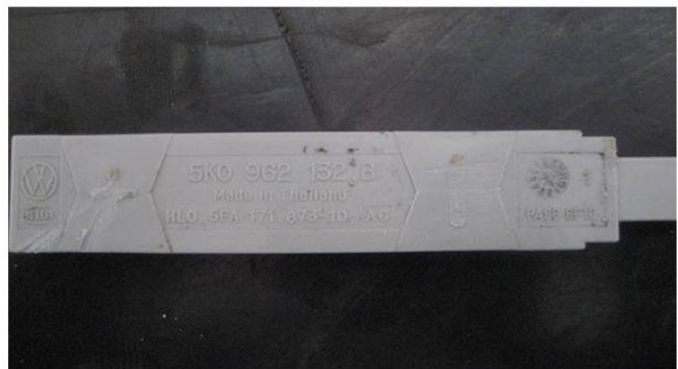
Figure 5. Removing the plastic locating pins from Aerial 1 (top image), and Aerial 1 with locating pins removed (bottom image).

7. Remove the two plastic locating pins on Aerial 1 so that no cables can chafe any components (Figure 5).

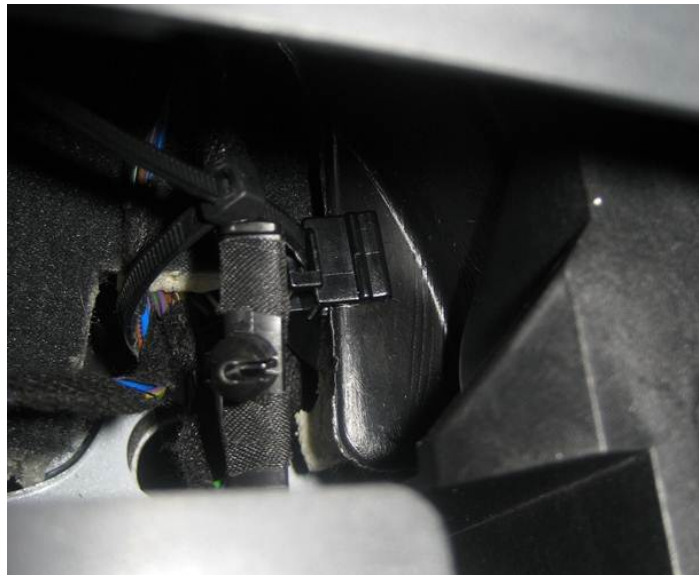
Figure 9. Zip tie needs tightening.

11. Tighten the zip tie and cut off any excess material (Figure 9). Rotate so that the sharp edge of the zip tie will not interfere with any cables in the area.
