Technical Service Bulletin

01 MIL on (DTC P0300, P130A, and/or P0301 through P0304)

01 13 95 2033561/1 May 13, 2013.

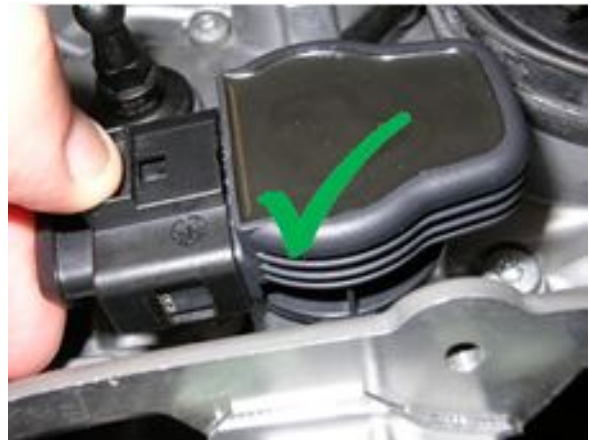
Figure 1. Correct method of disconnecting the ignition coil.

1. Confirm that misfire faults are stored in the ECM memory.
2. Disconnect the connectors from the ignition coils by first pushing the connector towards the ignition coil, then pulling the release tab with thumb, then pulling the connector off the ignition coil (Figure 1).

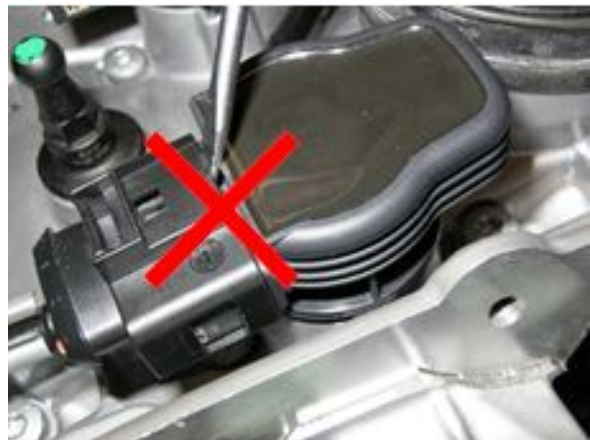
**Note:** Never use a screw driver, pick or any other tool to unlock and remove the connector, as damage to the connector may occur (Figures 2 and 3).

Figure 2. Incorrect method of disconnecting the ignition coil.
