IK0800284

Title: Ambient Air Temperature (AAT) Sensor Faults/Location/Diagnostics

Applies To: Navistar N13 Engines and Cummins ISX Engines Cummins ISB, N9 and N10

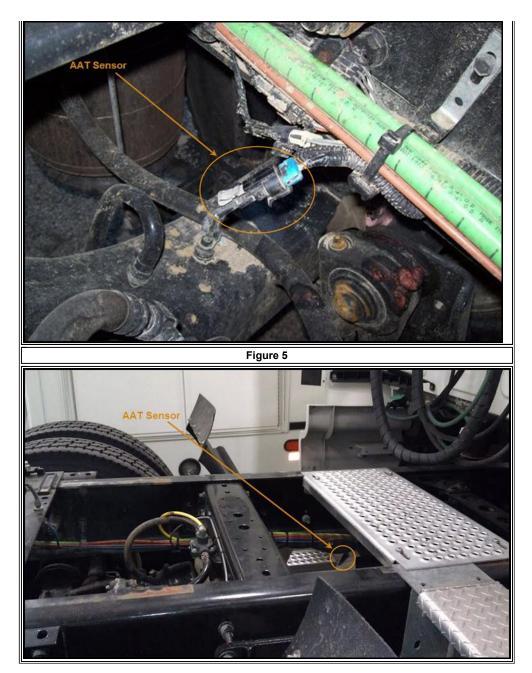
Big Bore Pre-SCR Engines and SCR Engine prior to August 2013:

The engine sensor is located on the left frame rail midway between the back of cab and front drive axle, or near the front drive axle. The two photos below show both possible mounting locations (*Figure 4 and Figure 5*).

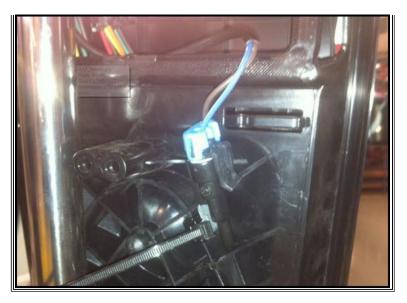
Big Bore Post August 2013 build w/SCR engine, driver's side mirror head (Figure 6):

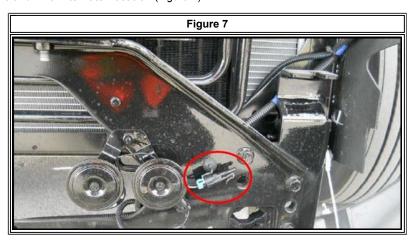
ISX15 and N13 Alternate Location (Figure 7):

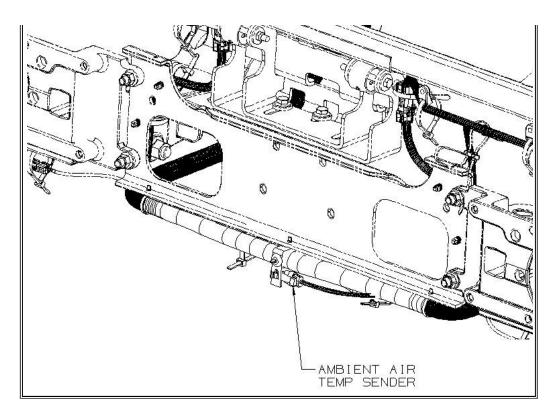
ISX15 and N13 Alternate Location PayStar / 9900i (Figure 8):

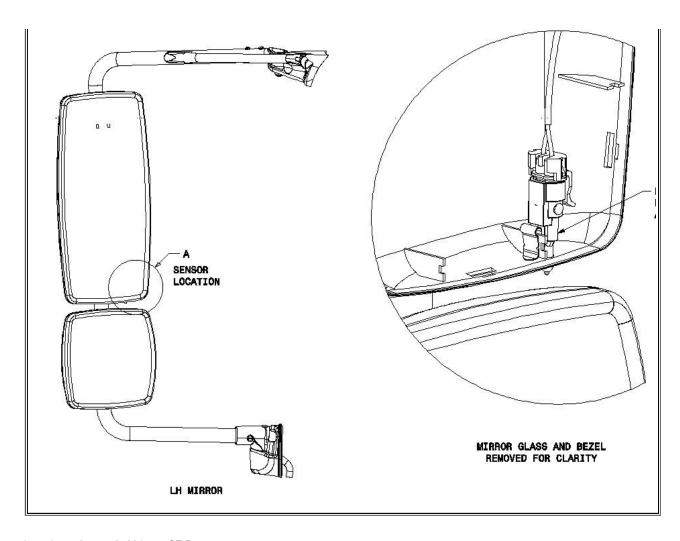
N9/10 and ISB engine platforms moved the Engine AAT to the driver mirror on August 8, 2014 (Figure 9):

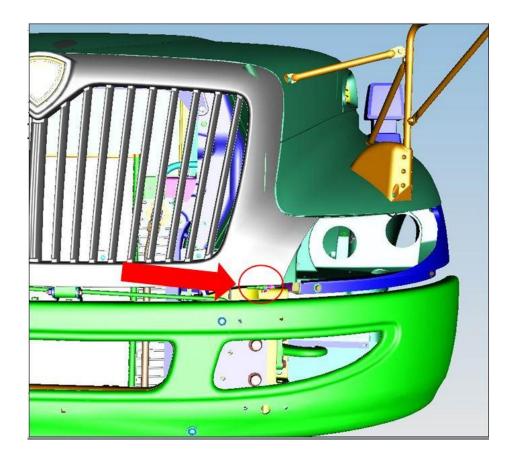
Location prior to August 8, 2014 on CE Bus
