Tech Tips

TT 72-12-02

2011-2012 Touareg – Front Seat Backrest is in a Different Position When Re-entering the Vehicle

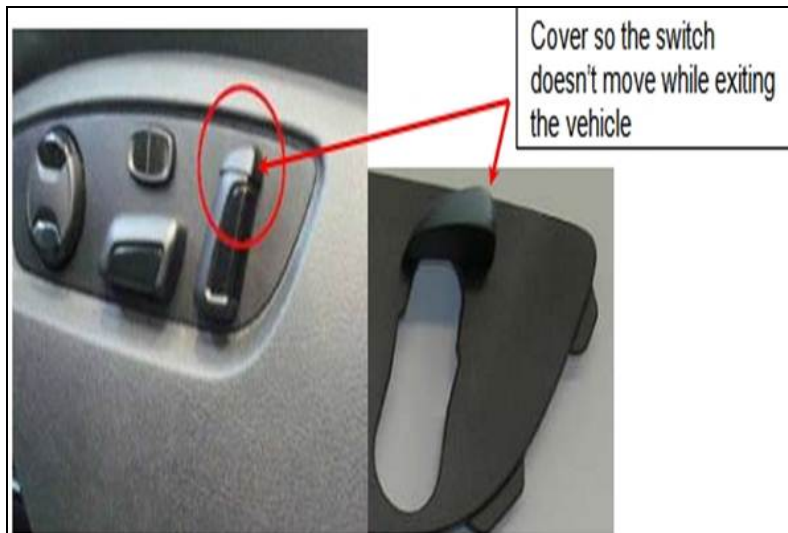
8-way seat trim

Customer concern of seat backrest in a different position when re-entering the vehicle may be caused by customer contacting backrest adjustment switch while exiting the vehicle. To prevent contact with switch, install updated switch trim panel with added cover over backrest adjustment switch as shown below. Backrest adjustment knob must also be replaced with part number 7P6959817B QWA (left) and 7P6959818B QWA (right). Be aware that the trim panel part number is based on vehicle trim level. Part numbers are as follows:

7P6.882.515E (driver side) / 7P6 882 516E (passenger side) Sport trim level (8-way seat)
