# PREVOST

## WARRANTY BULLETIN

**WB17-02**

DATE :	April 2017	SECTION :	23 ACCESSORIES
EXPIRATION:	April 2019		
SUBJECT :	ADDITION OF AN EXTENSION TO THE LINEAR THERMAL DETECTOR (LTD)

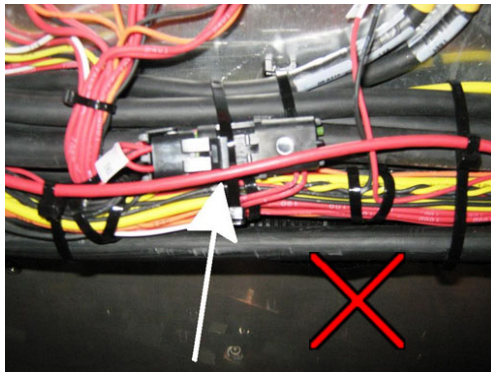
Possible contact or rubbing against screws, edges, etc.

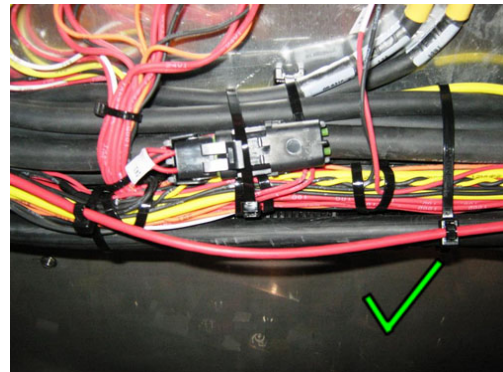
LTD must be routed clear of screws, sharp edges, etc.

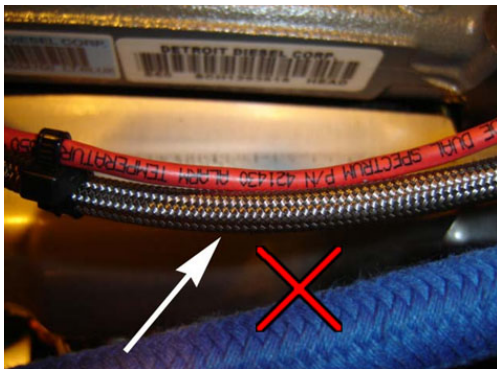
Rubbing or possible rubbing against abrasive surfaces

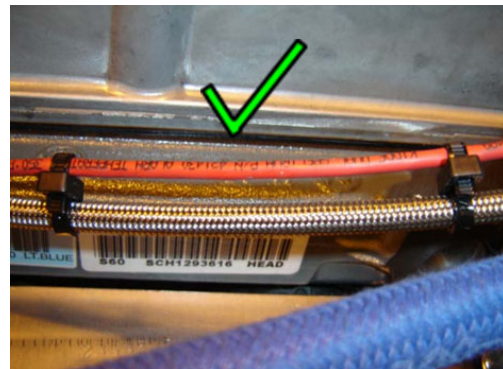
LTD must be secured with double loop cable ties. Distance between cable ties must not exceed 4 inches (100mm) max

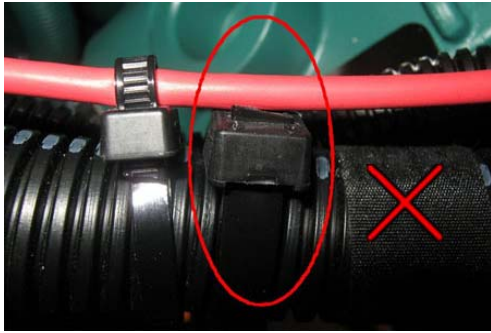
LTD touching cut cable tie

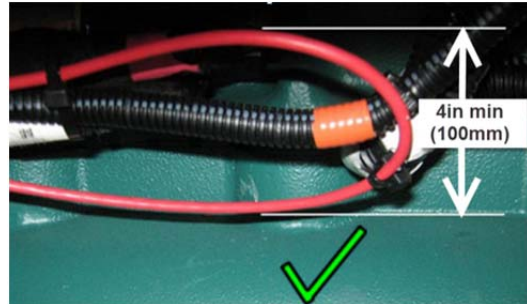
LTD is not a flexible harness. Avoid tight bends and kinks which could short circuit the LTD. Loops must have a minimum radii of 2 inches (50 mm)

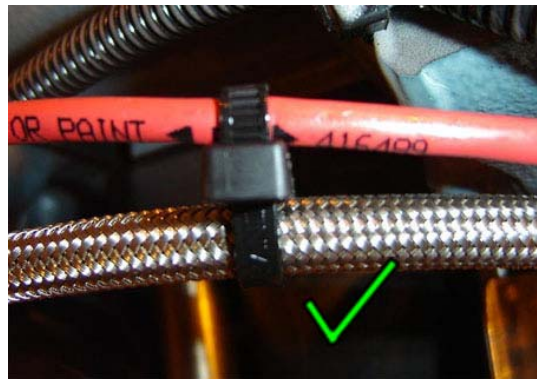
Proper tightening of the cable tie on the LTD
