Frame Rail Ground Stud
 VAH, VHD, VN

FSB 371-046, Frame Rail Ground Stud

(April 2014)

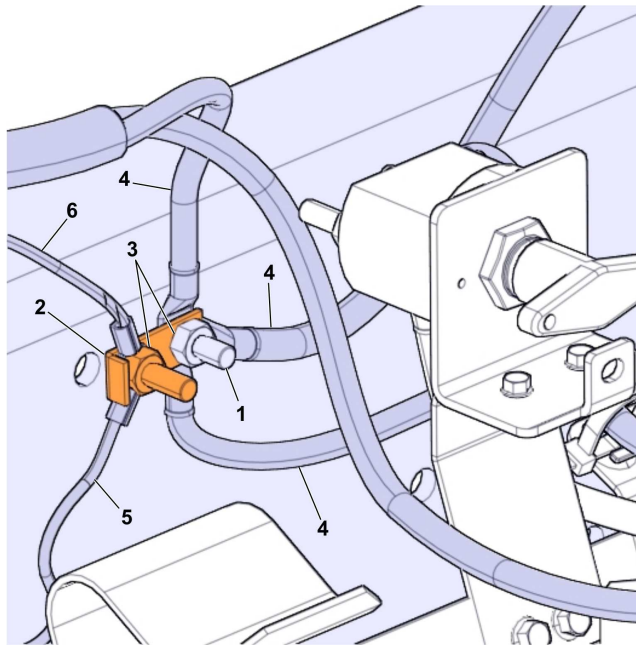
W3084050

On certain Volvo Trucks built from 01/01/2010 to 3/28/2014 the main ground stud, located on the frame rail behind the battery box, may have improper torque. This improper torque may have allowed corrosion inhibitor to get between the ring terminals which may cause multiple Diagnostic Trouble Codes and/or intermittent issues.

- 3 Secure the cable at the frame rail ground stud.

Note: If more than 3 cables are located on this grounding point, use the 21650178 buss bar to re-allocate the other cables for a more even distribution.

Note: Install the buss bar if needed over the largest cables and secure. Tighten to 40 ± 6 Nm (29.5 ± 4.5 ft lb).

Note: Install the smaller cables on the buss bar stud and secure. Tighten to 12 Nm (9 ft lb).

Note: If a washer is present on ground stud, discard and do not reuse.

Note: If adding buss bar check ring terminals for corrosion inhibitor and clean as necessary.
