**Tandem Fuel Pump Leakage**  
 VN, VHD, VT, VAH

**FSB 233-004, Tandem Fuel Pump Leakage**

(February 2014)

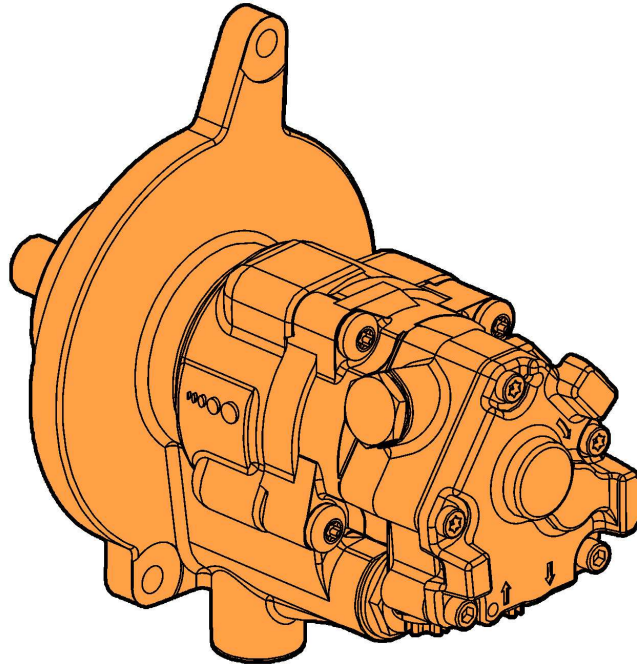
W2068238

The D11, D13, and D16 fuel pump is mounted on the back of the power steering pump as a tandem pump assembly. The shaft seal for the fuel pump and the shaft seal for the power steering pump, along with the weep hole are all contained within the power steering pump housing. Replacement of the fuel pump due to a fluid leak at the weep hole will not correct a weep hole leakage complaint. Refer to the cross sectional diagram in this document for additional information and views of the seal location.

If a fuel leak is encountered at the fuel pump, identify the source area of the leak and proceed as follows:

Tandem Fuel Pump Inspection	
Fuel Leak Location	Action
Fuel Pump Fittings	Service fittings and sealing washers as necessary.
Fuel Pump Mounting O-ring	Replace fuel pump mounting O-ring
Weep Hole	Replace tandem pump assembly.

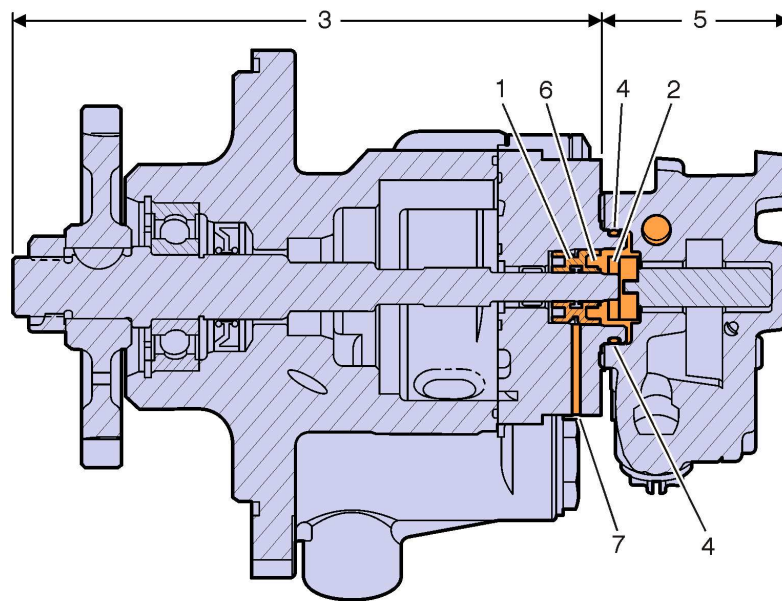
W2068239

Cross Sectional View of Tandem Pump Assembly	
Item Number	Description
1	Power steering seal and fuel seal both located in power steering pump
2	Drive Coupling
3	Power steering pump
4	Fuel pump mounting O-ring
5	Fuel pump
6	This space filled with fuel under normal operation
7	Weep hole for both power steering fluid and fuel
