Battery Cable Lug, Failure
 VN, VHD

FSB 371-045, Battery Cable Lug, Failure

(May 2013)

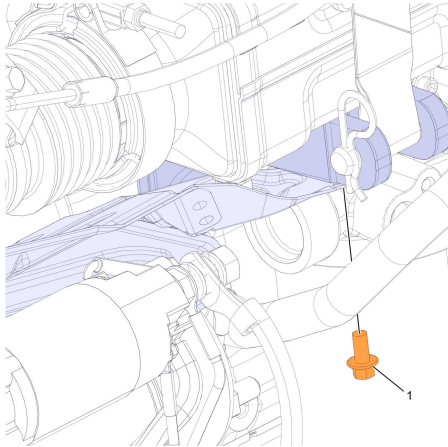
W2080360

1. Screw

- 1 Secure the vehicle for service by parking it on a flat level surface, applying the parking brake, chocking the rear wheel, and placing the transmission in neutral.
- 2 Disconnect all cables from the negative (ground) battery terminals to prevent personal injury from electrical shock and prevent damage to electrical components.
- 3 Remove the fastener from the heat shield bracket.

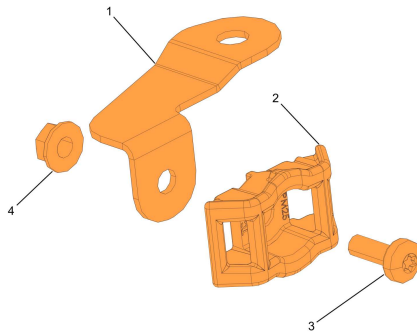
W2080361

1. Bracket
2. Saddle
3. Socket Screw
4. Nut

- 4 Preassemble the bracket and the saddle.

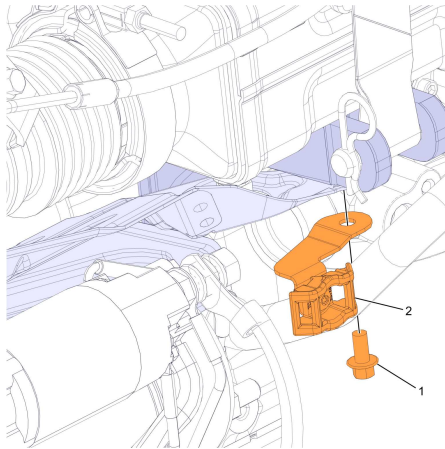
W2080362

1. Socket Screw
2. Saddle

- 5 Install the bracket onto the vehicle and secure.

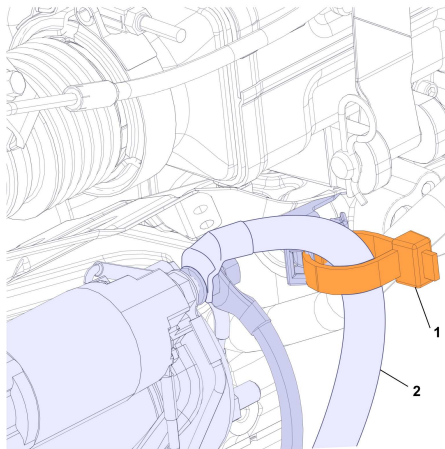
W2080364

Certain vehicles built from January 1, 2010 to May 28, 2013 with a D11 engines may experience cracking or breaking of the 90 degree positive battery cable lug at the starter solenoid stud. In some cases, the lug is bent during assembly, and along with engine vibration may cause the terminal to weaken and fail over time.

1. Cable Tie
2. Positive Battery Cable

- 6 Install the cable tie around the saddle and positive battery cable going to the starter solenoid.

Note: Battery cable may need to be loosened/retightened from back of starter solenoid in order to reach the saddle. Tighten to 26 ± 1.5 Nm (19.2 ± 1.1 ft lb).
