Front Spring Breakage VAH

SP 721-005, Front Spring Breakage

(October 2013)

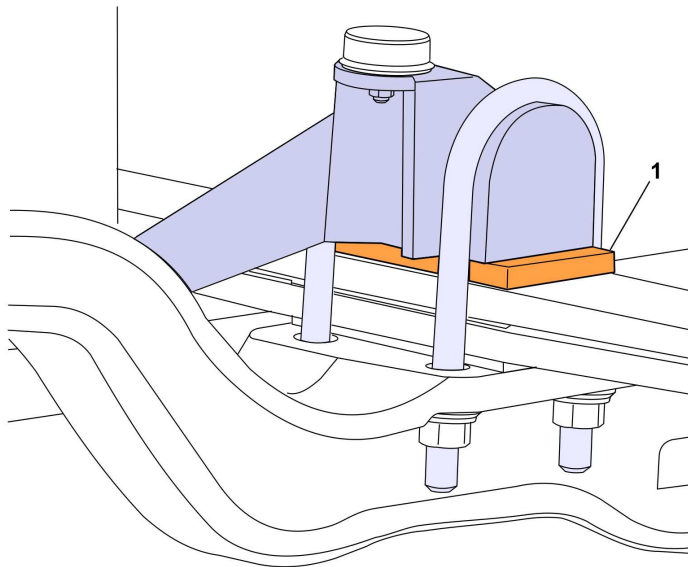
W7084034

It has been discovered on some VAH vehicles that the front springs can over travel. Over time this can lead to breakage of the spring leaf. A spacer plate will be installed to increase the height of the suspension bumpstops to limit spring travel.

- 1 Spacer to be added between top plate and leaf spring.
 - 7 Remove the top plate over the spring assembly.
 - 8 Install the new spacer onto the spring assembly.
 - 9 Install the top plate, new U-bolts and nuts and secure. Torque to 550 ± 25 Nm (406 ± 18 ft-lb).
- Note:** Tighten evenly in an X - pattern.
- 10 Install the lower shock mounting fastener. Torque to 415 ± 40 Nm (306 ± 30 ft-lb).
 - 11 Perform these same steps on the other side of the vehicle.
 - 12 Jack the steer axle up and remove jack stands and let axle down.
 - 13 Remove wheel chocks.
 - 14 Lower hood.
