Date 10.13 Group **284** No. **047** Release **02** Page 1(10)

Oil Level Sensor Harness Wire Splice
 VAH, VHD, VN, VT

FSB 284-047, Oil Level Sensor Harness Wire Splice

(October 2013)

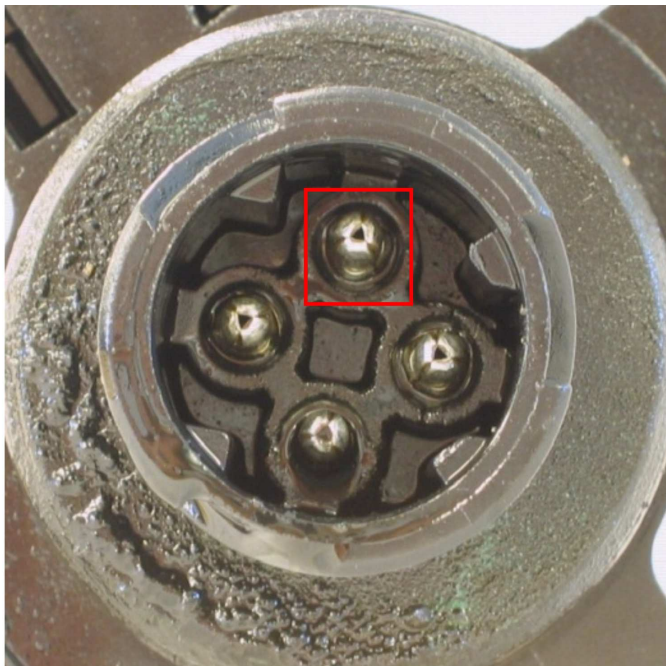
W2085817

Some VOLVO vehicles built between January 2004 and September 19, 2013 may experience an oil level sensor failure that leads to oil contamination into the engine wire harness. A new anti-wicking pigtail splice kit, part number 85137983, is now available. Follow the procedure below if wicking is observed. Chassis with build date September 20, 2013 and later have the new solid pin connector and no action is required. The oil level sensor part number 21521353 with hollow pin type connector is now replaced with the new solid pin type connector oil level sensor part number 22022794. The new solid pin connector does not allow oil to wick into the engine harness.

Old Style Hollow Pin Connector
