Seat Harness Routing (Non-Swivel)
 VN, VHD, VAH

FSB 375-010, Seat Harness Routing (Non-Swivel)

(March 2014)

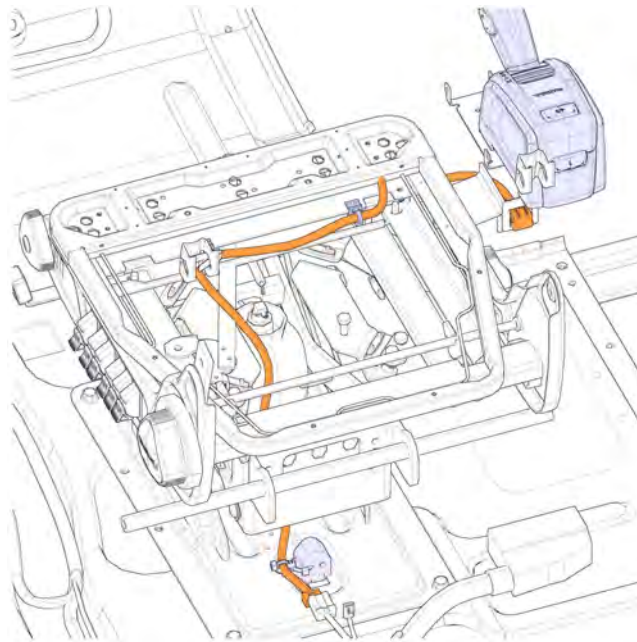
W3076418

Vehicles equipped with a driver side non-swivel seat and I shift transmission, built prior to October 20, 2013, may experience the seat harness being crushed by seat base, which may cause wire chaffing/damage.

To correct the situation a new routing has been implemented to prevent the above failures.

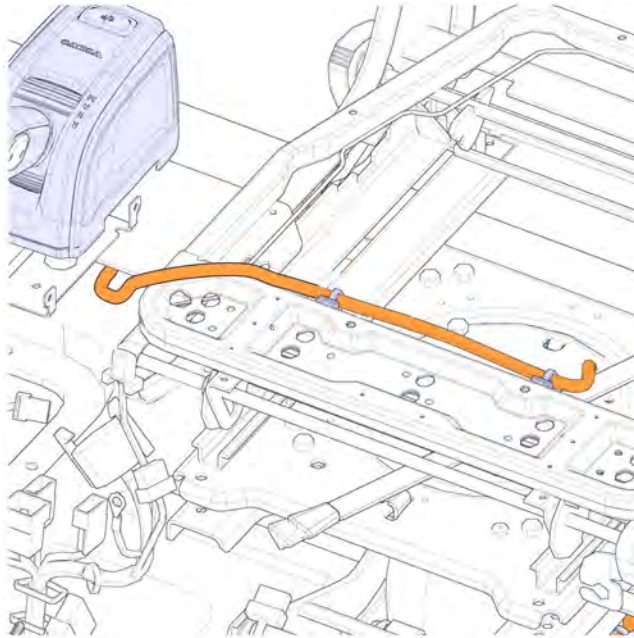
W3088546

- 4 Look for chafed wires under seat base. Reuse harness if undamaged. If damaged repair as necessary.
