Date 5.2015    Group **215**    No. **002**    Release **02**    Page 1(2)

Timing Plate Leak Repair  
 D16  
 VN, VT

**FSB 215-002, Timing Plate Leak Repair**

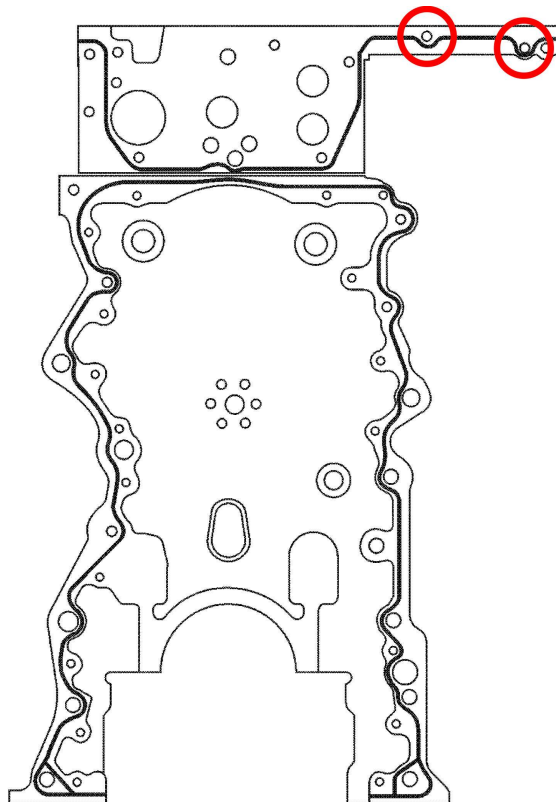
W2098874

Oil leaks have been observed coming from the area that is at the rear of the engine, just under the lip of the valve cover, on the right side (exhaust side). It is typically seen as seeping, weeping, leaking oil and could be believed to be from the cylinder head gasket. Deeper investigation has found that the bolts (highlighted in the images below) that fasten the timing plate to the cylinder head are coming loose, which breaks the silicone seal and will allow oil to start leaking. This issue is only applicable to D16 engine serial numbers prior to 80059.

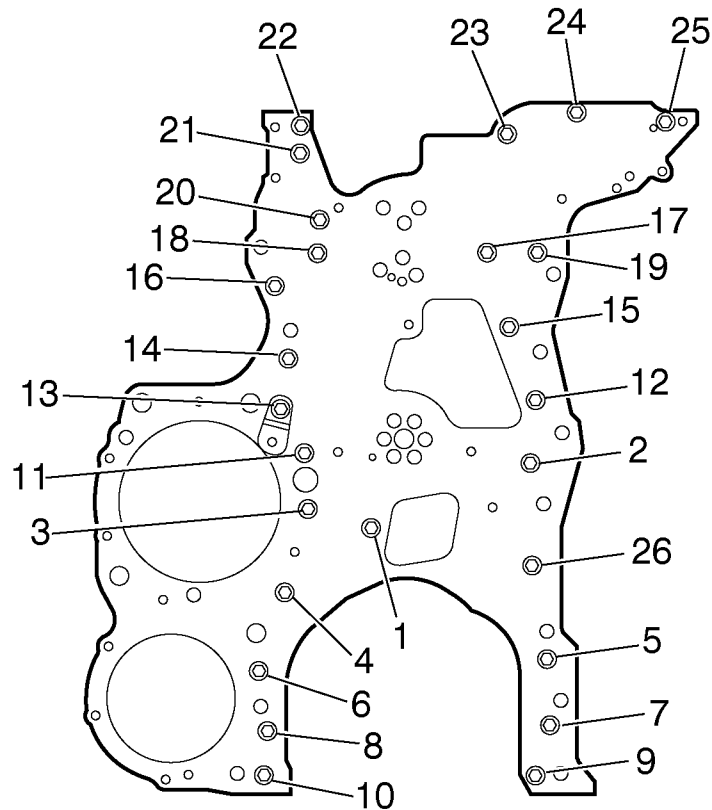
W2005981

**Note:** Numbers in image indicate tightening sequence.

The repair for this requires gaining access to the rear of the engine block. Refer to the appropriate service information in Impact. It may be necessary to replace the timing plate if the plate is fretted severely. Thoroughly clean the block, fasteners and fastener holes. Replace all 25 M8\*25 timing plate screws with part number 994447 which have pre-applied locking compound (patch-lock).
