Solution K11065398 Tuesday, December 5, 2017 9:10:10 PM CET

Mack Chassis - Crankcase Venilation (CCV) Oil Leaks - US14 Emissions And Newer

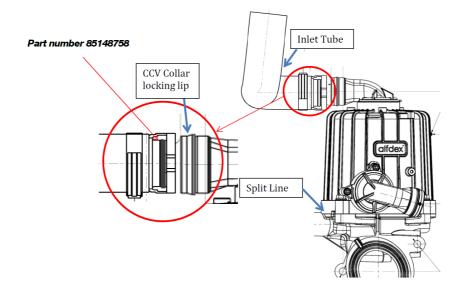
Mack Trucks has received reports from the aftermarket regarding oil leaks at the CCV housing inlet tube and at the split line between the upper and lower housings on chassis

builds between **January 1, 2014 and January 26, 2016** with MP7, MP8, and MP10 engines. It has been determined that the O-ring installed on the inlet tube is the source of the leak and oil may leak down the back of the housing giving the impression that the housing split line is also leaking.

Should there be a report of this nature on a chassis built after January 1, 2014, do not disassemble the CCV. Remove the inlet tube assembly and carefully replace the O-ring at the quick connect fitting with part 85148758 using an O-ring pick. Be careful to not scratch the plastic quick connect housing with the O-ring pick during this procedure as this may cause an oil leak. Return the parts through normal warranty procedures if requested. If it is determined that there is a leak at the housing other than the inlet O-ring, the complete assembly will need to be replaced as this is a non-serviceable part. Do not attempt to tighten the split line screws on the housing or disassemble the assembly as seals and repair parts are no longer available for this component as they were on the older version of this component. *NEW - If the quick connect fitting is cracked or breaks on disassembly, replace the complete tube assembly. If the collar on the CCV inlet is worn or broken at the locking lip, replace the complete CCV assembly.*
