| GROUP ENG | MODEL 2017-2018MY Forte (YDm) 2.0L MPI |
| NUMBER 181 | DATE December 2017 |

TECHNICAL SERVICE BULLETIN

SUBJECT: SERVICE ACTION: IGNITION COIL OR COIL RFI
SPRING REPLACEMENT FOR DTC P030X (SA321)

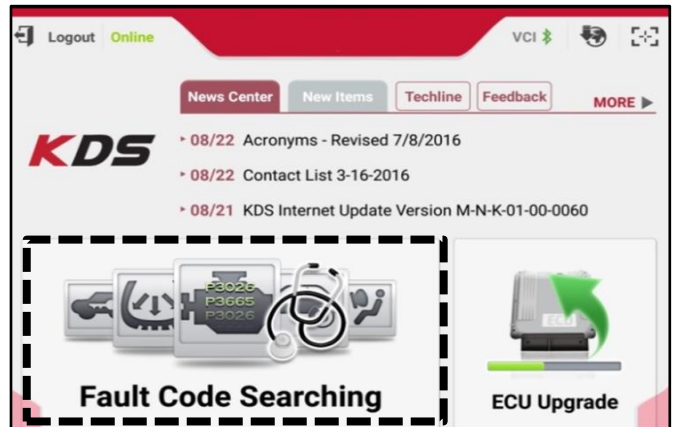
1. If the MIL is on, perform a Fault Code Search for any Engine related DTCs then proceed to the next step (2).

If the MIL is not on, proceed to the RFI Replacement Procedure below.
