**Road noise heard from B-pillar**

<b>REF NO:</b> TJ 30853.2.0	<b>ISSUING DEPARTMENT:</b> Technical Service	<b>CAR MARKET:</b> United States and Canada	
<b>PARTNER:</b> 3 US 7510 Volvo Car USA		<b>ISSUE DATE:</b> 2015-11-09	<b>STATUS DATE:</b> 2016-07-11
<b>FUNC GROUP:</b> 8000	<b>FUNC DESC:</b> Body, cab and interior	Page 1 of 10

TJ 30853

<b>Title</b>	B-pillar trim panel	<b>Page</b>	1 ( 8 )
<b>Action</b>	Removal	<b>Operation number:</b>	98615-2

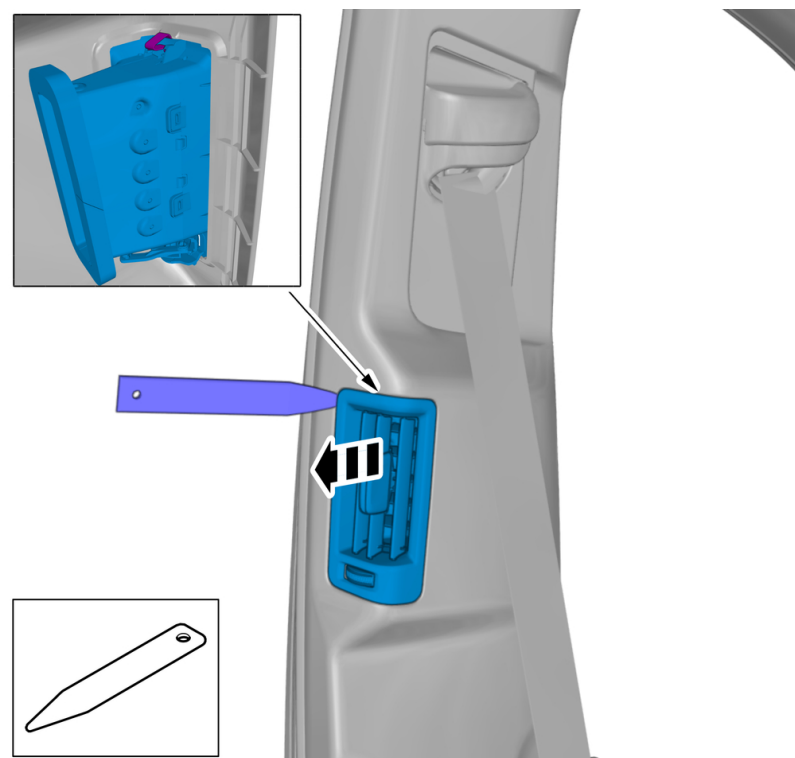
Remove the marked part.  
On both sides.
