## TECHNICAL SERVICE BULLETIN

### 1.5L GTDI - Illuminated Malfunction Indicator Lamp (MIL) - Diagnostic Trouble Code (DTC) P051B - Built On Or Before 1-Feb-2017

**17-2236**

Ford 2017 Escape
---------------------

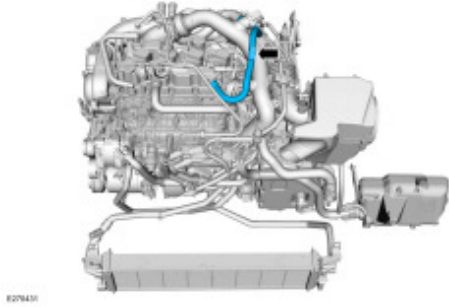
Figure 1

**Issue:** Some 2017 Escape vehicles equipped with a 1.5L Gasoline Turbocharged Direct Injection (GTDI) engine and built on or before 1-Feb-2017 may exhibit an illuminated MIL with DTC P051B.

- Check the vehicle build date. Was the vehicle built on or before 1-Feb-2017?
  - Yes - proceed to Step 2.
  - No - this article does not apply. Refer to the Powertrain Control/Emissions Diagnosis (PC/ED) manual for normal diagnostics.
- Connect the Ford Integrated Diagnostic System (IDS) service tool or Ford J2534 Diagnostic Software (FJDS) to the data link connector (DLC). Check for DTCs. Is P051B stored in the powertrain control module (PCM)?
  - Yes - proceed to Step 3.
  - No - this article does not apply. Refer to the Powertrain Control/Emissions Diagnosis (PC/ED) manual for normal diagnostics.
- Remove cowl panel. Refer to Workshop Manual (WSM), Section 501-02.
- Remove and replace the crankcase pressure sensor/tube assembly. (Figure 1)

**5. To install, reverse the removal procedure.**
