Eliminating Noise Symptoms - Replacing Exhaust Pipes (Humming noise from around exhaust system 20/16)

Revision: This bulletin replaces ATI Group 2, #1503, dated July 23, 2015.

Model Year: **As of 2014 up to 2016**

Vehicle Type: **Macan S, Macan GTS, Macan Turbo**

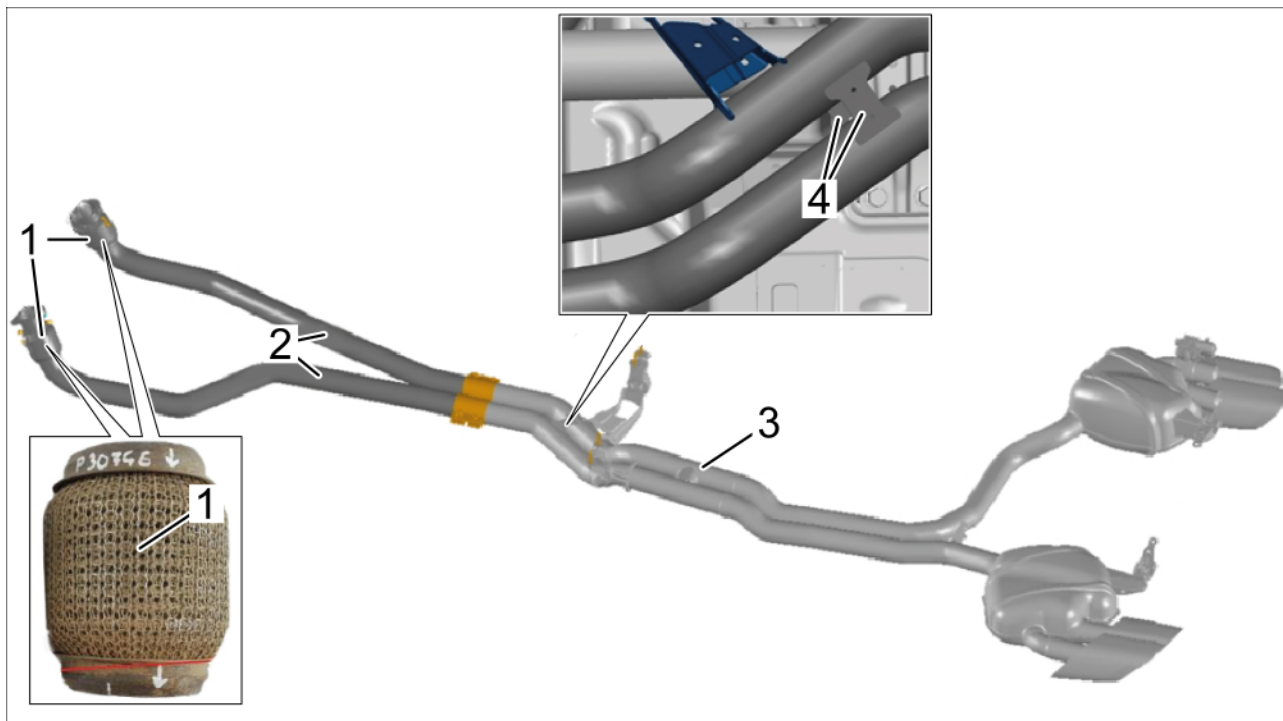
Cause - exhaust system

Symptom: **Customers complain of a humming noise coming from around the exhaust system.**

Cause: The dynamic rigidity of the decoupling elements ⇒ *Cause - exhaust system -1-* on the exhaust gas connecting tubes ⇒ *Cause - exhaust system -2-* is too low. Due to lack of insulation, the filler plates ⇒ *Cause - exhaust system -4-* on the rear exhaust pipe ⇒ *Cause - exhaust system -3-* can break.

Remedial Action: In the event of a customer complaint, only the exhaust gas connecting tubes must be replaced and **new** connecting tubes with modified decoupling elements must be fitted.

If the filler plates on the rear exhaust pipe are broken, remove the filler plates.
