LTB00836NAS4

TECHNICAL BULLETIN

501-05: Interior Trim and Ornamentation

Tailgate Trim Panel Detached From Tailgate

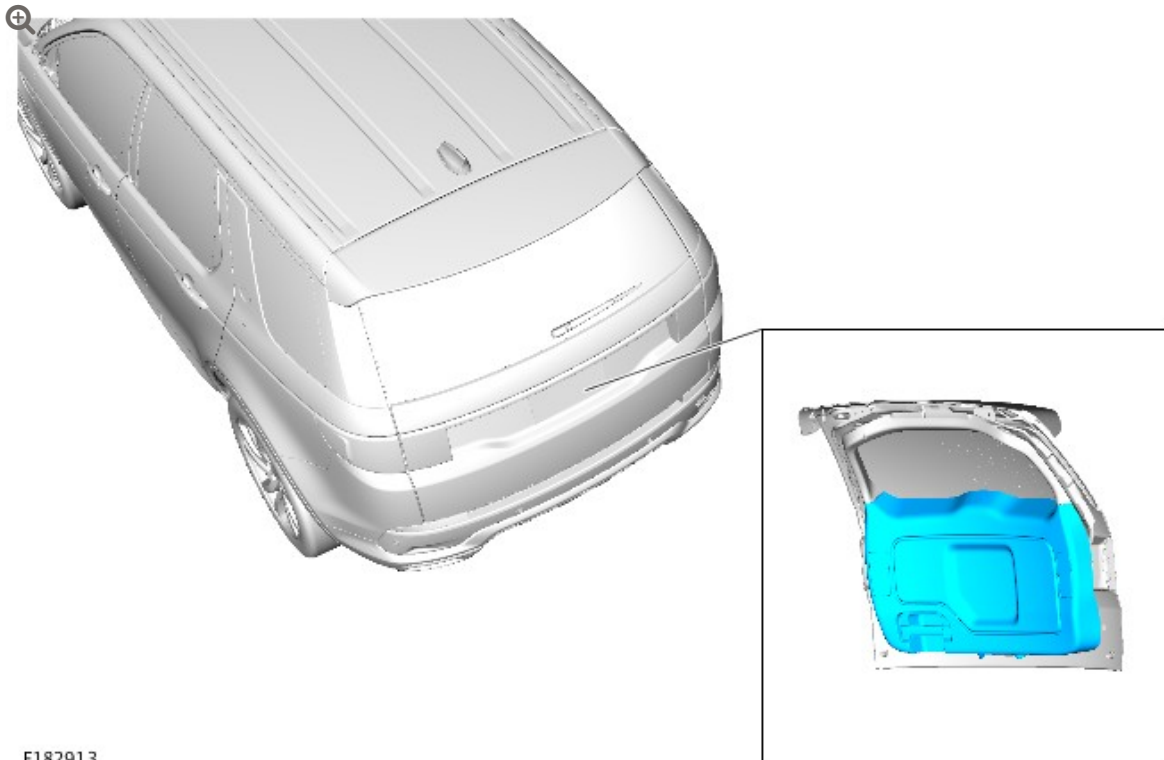
E182913

Component location.
