**Title (customer effect)** Volvo Chassis - Crankcase Ventilation ( CCV ) Oil Leaks - US14 Emissions And Newer

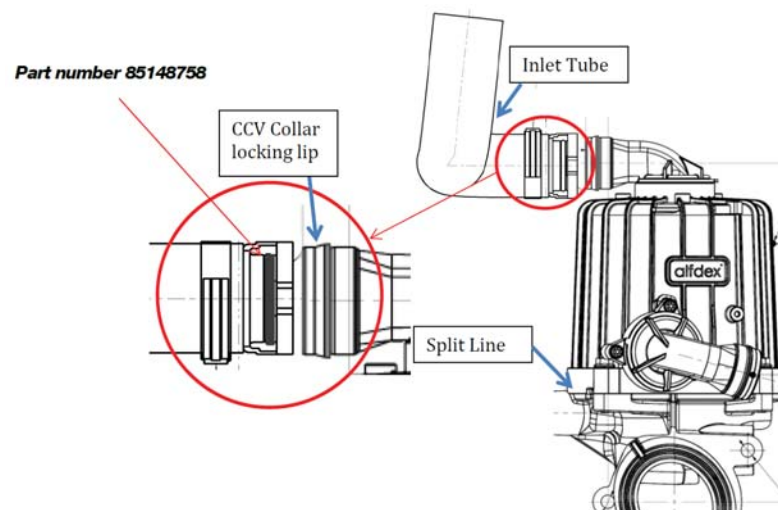
**Cause** Volvo Trucks has received reports from the aftermarket regarding oil leaks at the CCV housing inlet tube and at the split line between the upper and the lower housings on chassis builds **between January 1, 2014 and January 26, 2016** with D11, D13, and D16 engines. It has been determined that the O-ring installed on the inlet tube is the source of the leak and oil may leak down the back of the housing giving the impression that the housing split line is also leaking.

Should there be a report of this nature on a chassis built after January 1 2014, do not disassemble the CCV. Remove the inlet tube assembly and carefully replace the O-ring at the quick connect fitting with part 85148758 using an O-ring pick. Be careful to not scratch the plastic quick connect housing with the O-ring pick during this procedure as this may cause an oil leak. Return the parts through normal warranty procedures if requested. If it is determined that there is a leak at the housing other than the inlet O-ring, the complete assembly will need to be replaced as this is a non-serviceable part. Do not attempt to tighten the split line screws on the housing or disassemble the assembly as seals and repair parts are no longer available for this component as they were on the older version of this component. ***NEW - If the quick connect fitting is cracked or breaks on disassembly, replace the complete tube assembly. If the collar on the CCV inlet is worn or broken at the locking lip, replace the complete CCV assembly.***
