JAGUAR LAND ROVER SHOP FOREMAN CONFERENCE CALL
DECEMBER 14, 2017

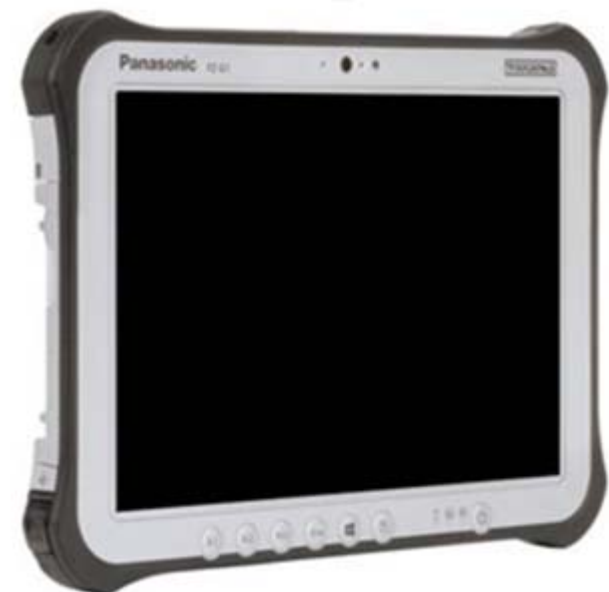
- Panasonic Tablet with 256GB hard drives run out of memory space

- A fix is now in place to adjust the hard drive partition size

- Please submit a Diagnostic EPQR for the concern
- Additionally call Bosch Technical Support at 1-866-628-5508 for assistance with hard drive partitioning adjustments

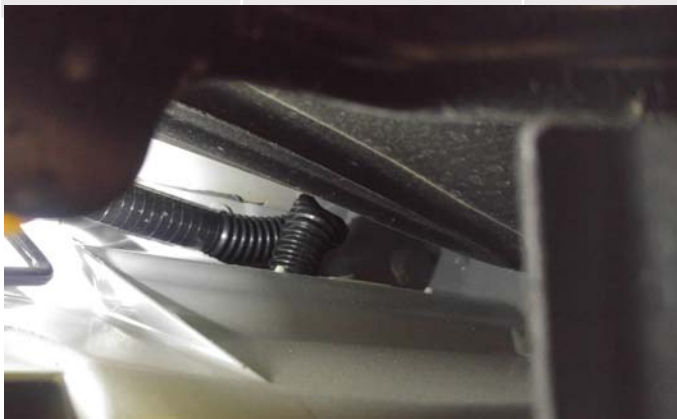
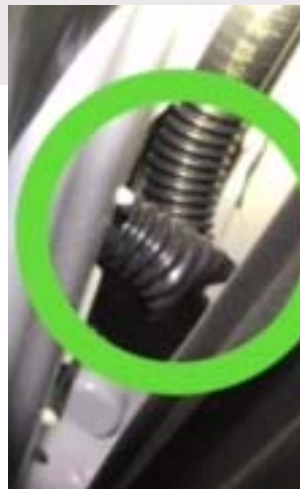
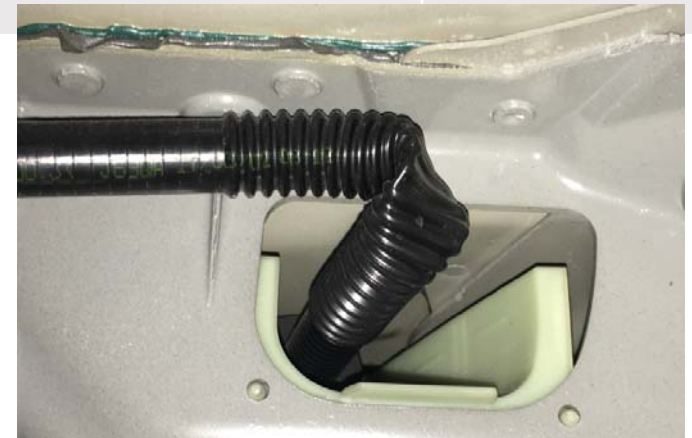
Vehicle	Customer Concern	Details and Status	Publication
F-PACE RR Velar 18MY	A customer may report that Eco Stop/Start is not functional.	Diagnostic information is available in Live Data within the GWM via Pathfinder. There is a list of stop/start inhibits and a value "Estimated cold cranking voltage at present state of charge [41EA]" which is a calculated value that will inhibit operation of Eco Stop/Start. This data must be included in a TA for additional support.	Under Investigation
Discovery 17MY	A Customer may report vehicle is hard to fill with fuel.	Inspect fuel tank vent line for restrictions due to a twisted line. If this is identified post VIN end A044489, please raise an EPQR.	TBD

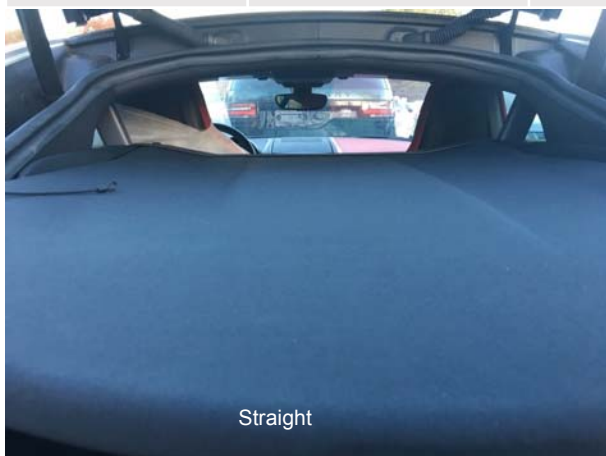
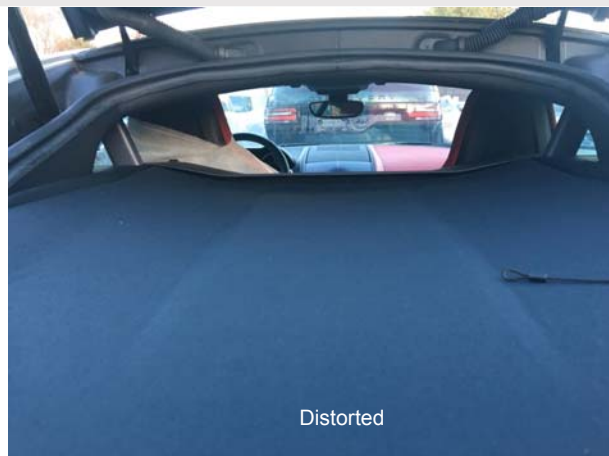
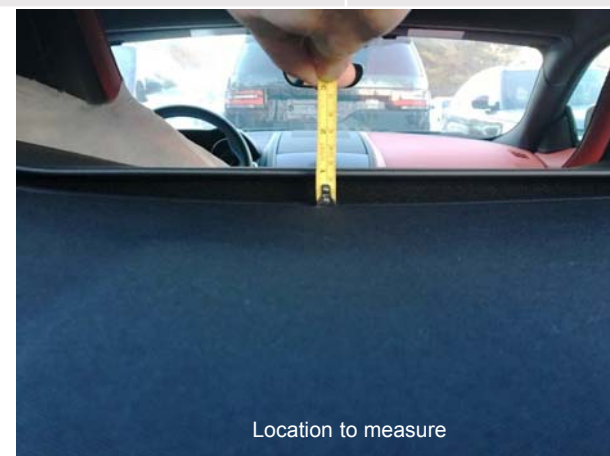
Vehicle	Customer Concern	Details and Status	Publication
Discovery	A Customer may report difficulty in opening the hood.	A few reports have been received regarding difficulty opening the hood panel when the release level is pulled. The reports suggest that the cable is too long for the application and does not pull far enough to release the hood latches. This concern is currently being investigated. Should this concern be found please submit an EPQR for the vehicle to aid in the investigation.	Under Investigation
F-TYPE Coupe	A Customer may report the load space cover is warping.	A Customer may find the Parcel Shelf (load space cover) is distorting, lowering in the center. This concern is currently under investigation. If you find any cases of this concern please submit an EPQR with picture showing the amount of distortion.	Under Investigation
