Technical Service Bulletin

40 Clicking noise from wheel bearing

40 17 66 2024318/6 June 19, 2017. Supersedes Technical Service Bulletin Group 40 number 17-61 dated April 17, 2017 for reasons listed below.

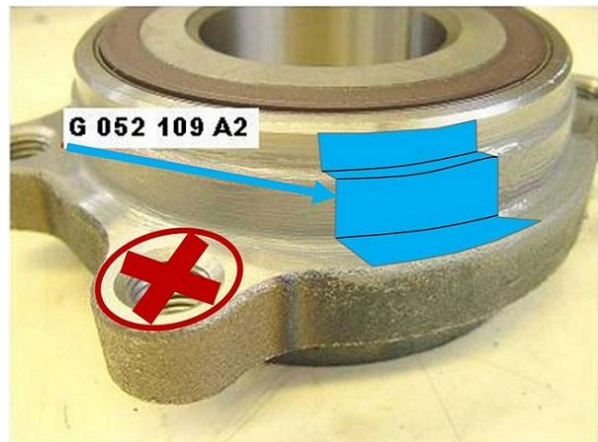
Microscopic movements between the wheel bearing and wheel bearing housing may cause the noise (front left and/or front right bearing can be affected).

Figure 1. Area to apply paste.

1. On the affected side(s), remove any corrosion and dirt from the wheel bearing housing and the wheel bearing.
2. Using a brush, apply a thin coat of paste part number G 052109A2, using about .21 ounces or 6 grams (roughly 1/20) from the tube on the wheel bearing housing as shown (Figure 1). Make sure not to apply any paste on the threads.
