Service Action

Code: 21F2

Subject	ECM Software and/or Coolant Line Seals
Release Date	June 28, 2017
Revision Summary	Work instructions updated.
Affected Vehicles	U.S.A. & CANADA: Certain 2013-2015 MY Audi vehicles with 4.0L TFSI Engine <ul style="list-style-type: none">• 2013-2015 MY Audi A6/A7, S6/S7• 2013-2014 MY Audi A8/S8• 2014-2015 MY Audi RS7 <p><i>Check Campaigns/Actions screen in Elsa on the day of repair to verify that a VIN qualifies for repair under this action. Elsa is the <u>only</u> valid campaign inquiry & verification source.</i></p> <ul style="list-style-type: none">✓ Campaign status must show "open."✓ If Elsa shows other open action(s), inform your customer so that the work can also be completed at the same time the vehicle is in the workshop for this campaign.
Problem Description	On Audi vehicles with 4.0L TFSI engines manufactured within a specific period, the O-rings in the coolant lines for the turbocharger may be damaged. This can result in leaks between the coolant lines and the turbocharger.

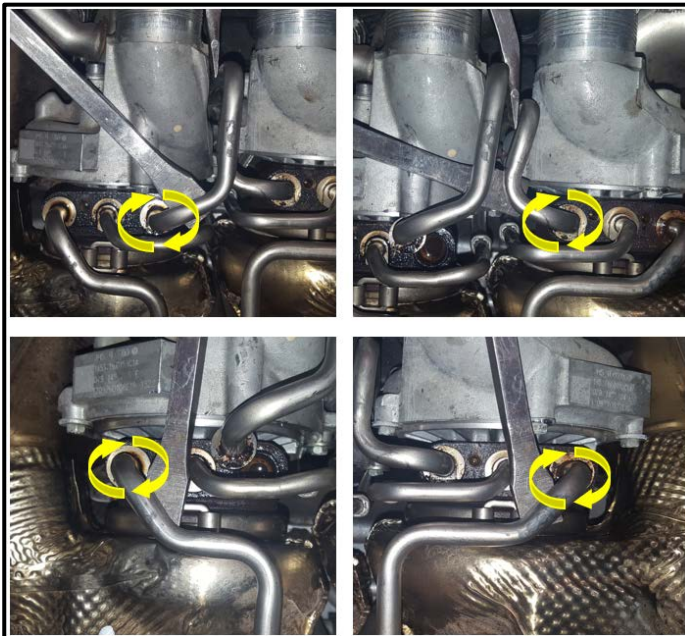
When removing seized coolant lines from the turbo:

- Use penetrating oil around the pipe to turbo connection.
- LIGHTLY tap each side of the coolant line near the connection with a small hammer.
- DO NOT attempt to remove the pipe until the pipe can be moved back and forth.
- DO NOT rock the pipe in a manner that will put force against the turbo housing.
- DO NOT remove or disturb the oil feed pipes.
- Rotate the lines gently back and forth until the connection is rotating in the turbo housing.
- Once the connection is moving freely, pry up on the pipe with slight even pressure using a pry bar while rotating the pipe back and forth.
