Technical Service Bulletin

91 Generation 3 CAN radio: CD drive malfunction

91 17 33 2021780/6 July 14, 2017. Supersedes Technical Service Bulletin Group 91 number 15-05 dated July 22, 2015 for reasons listed below.

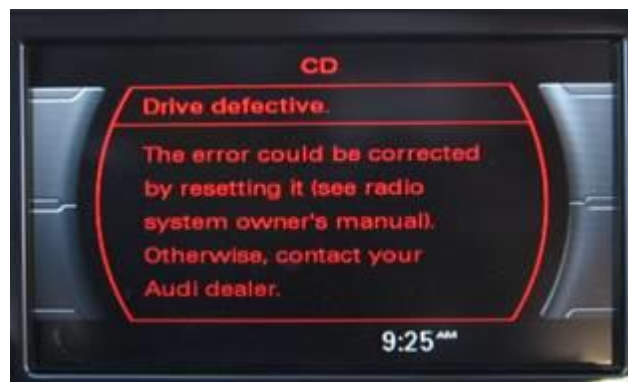
- The following sequence of error messages is seen on the radio display screen after a CD was loaded into or removed from the internal CD drive:
- “Drive defective.
The error could be corrected by resetting it (see radio system owner’s manual).
Otherwise, contact your Audi dealer.”
(Figure 1)

Figure 1. The “Drive defective” error message.

1. Do not replace the radio. The CD drive is fully functional after an ignition cycle or radio reset is performed.
2. Erase and ignore the CD drive faulty DTC.
3. Explain the behavior to the customer to prevent a reoccurrence of the concern.

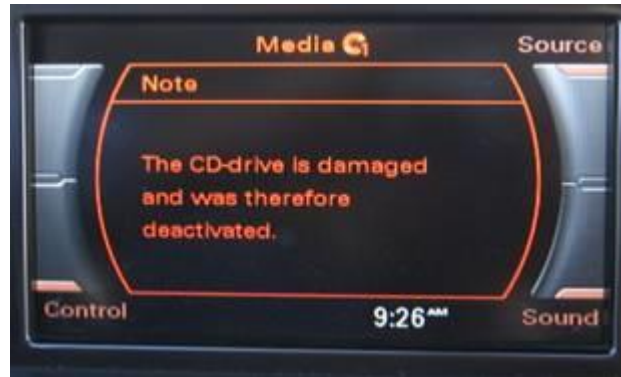
- “The CD-drive is damaged and was therefore deactivated.” (Figure 2)

Figure 2. The “damaged CD drive” error message.

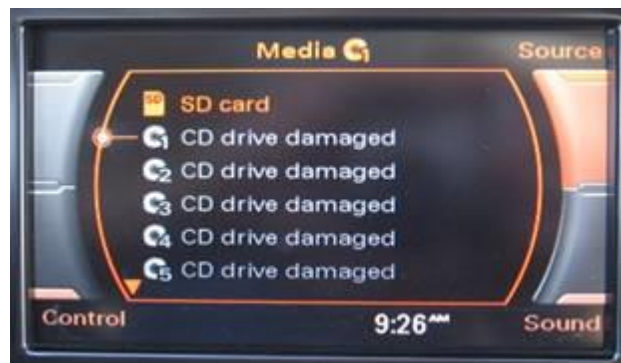
- The CD drive cannot be selected in the Source list and is described as “damaged.” (Figure 3)

Figure 3. CD drive is not available in the Source selection screen.
