Technical Service Bulletin

01 MIL on (DTCs P200400, P200500, P200600 and/or P200700) stored in ECM

01 17 27 2048411/2 July 19, 2017. Supersedes Technical Service Bulletin Group 01 number 17-26 dated July 19, 2017 for reasons listed below.

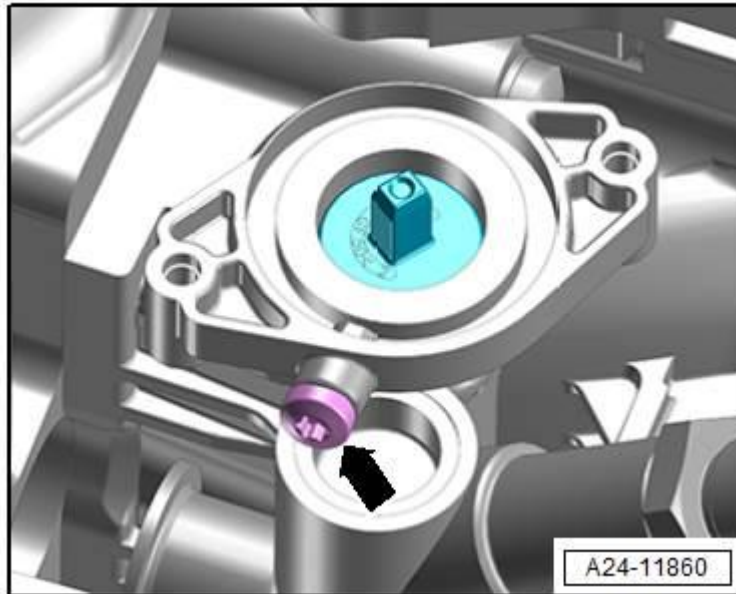
Figure 1. Micro-encapsulated bolt (A24-11860 of repair manual).

When replacing the potentiometer, the micro-encapsulated bolt of the potentiometer (Figure 1) must be replaced. The micro-encapsulated bolt is included in repair kit 079198135.
