Technical Service Bulletin

40 Clicking noise from wheel bearing

40 17 68 2024318/7 July 11, 2017. Supersedes Technical Service Bulletin Group 40 number 17-66 dated June 19, 2017 for reasons listed below.

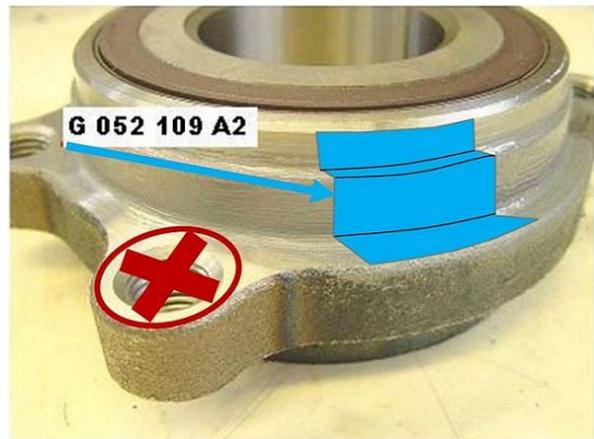
Microscopic movements between the wheel bearing and wheel bearing housing may cause the noise (front left and/or front right bearing can be affected).

Figure 1. Area to apply paste.

1. On the affected side(s), remove any corrosion and dirt from the wheel bearing housing and the wheel bearing.
2. Using a brush, apply a thin coat of paste part number G 052109A2, using about .21 ounces or 6 grams (roughly 1/20) from the tube on the wheel bearing housing as shown (Figure 1). Make sure not to apply any paste on the threads.
