Technical Service Bulletin

94 Exterior lights, moisture accumulation

94 17 91 2012749/13 July 31, 2017. Supersedes Technical Service Bulletin Group 94 number 15-65 dated April 17, 2015 for reasons listed below.

Model(s)	Year	VIN Range	Vehicle-Specific Equipment
All	1996 - 2019	All	Not Applicable

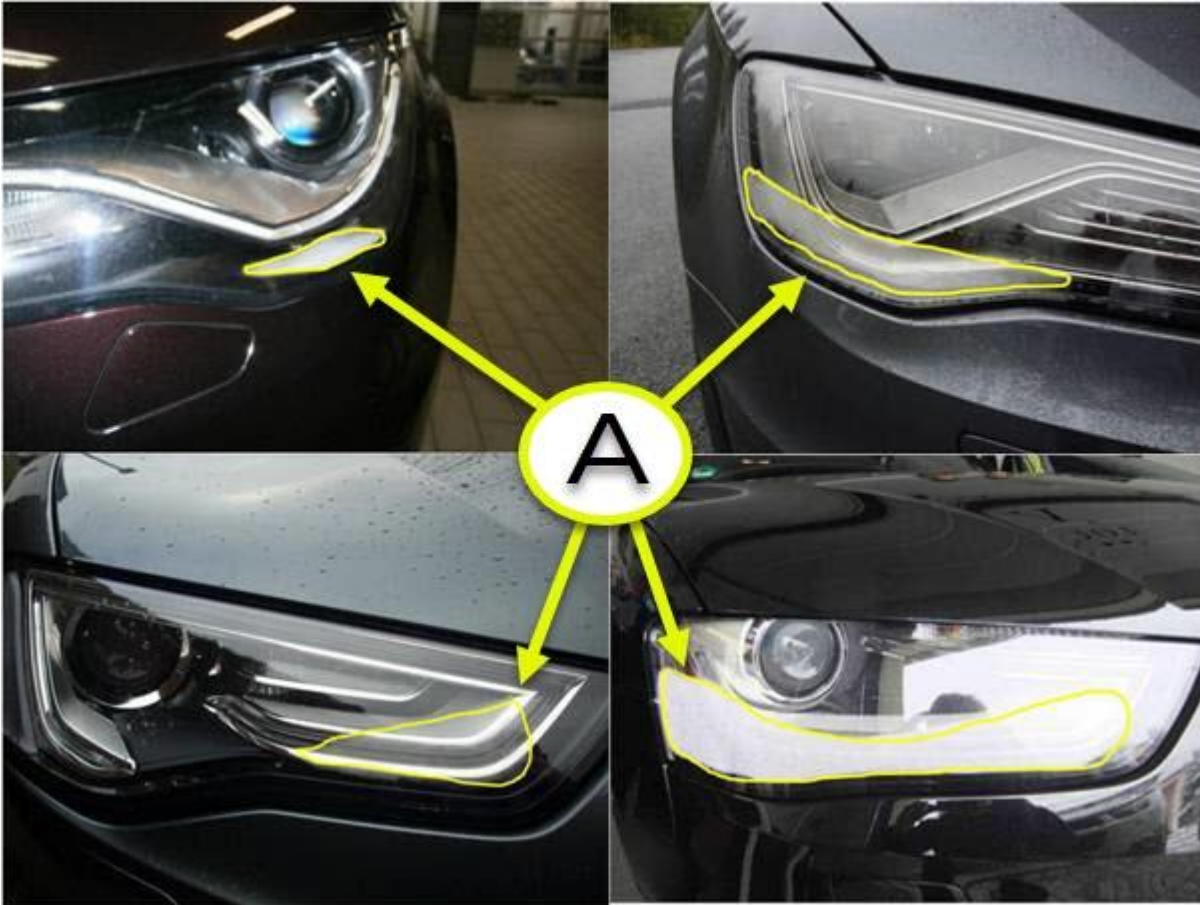
Condensation is visible on the inside of the headlight, taillight, fog light, side marker light, front turn signal, daytime running lights, and/or third brake light lens (Figure 1).

Figure 1. Condensation on the inside of the lights.

The headlight ventilation system allows air from the exterior of the assembly to pass through the headlights. This open water-protected ventilation system (which is needed for pressure compensation) creates different climate zones in the headlight: very warm areas, where the lens is warmed up by the light, and relatively cool areas, where the lens is cooled down by the airflow.

Considerable differences in humidity and temperature between the inside and the outside of the headlights, even when the car is being driven, can create condensation. While condensation is most common in cold and wet weather, it can also occur after a car wash, or when the temperature changes. Condensation is more visible on lenses made of clear glass than on lenses with patterns. The moisture does not affect the headlight function or light performance, and it does not lead to corrosion or damage of other headlight parts.

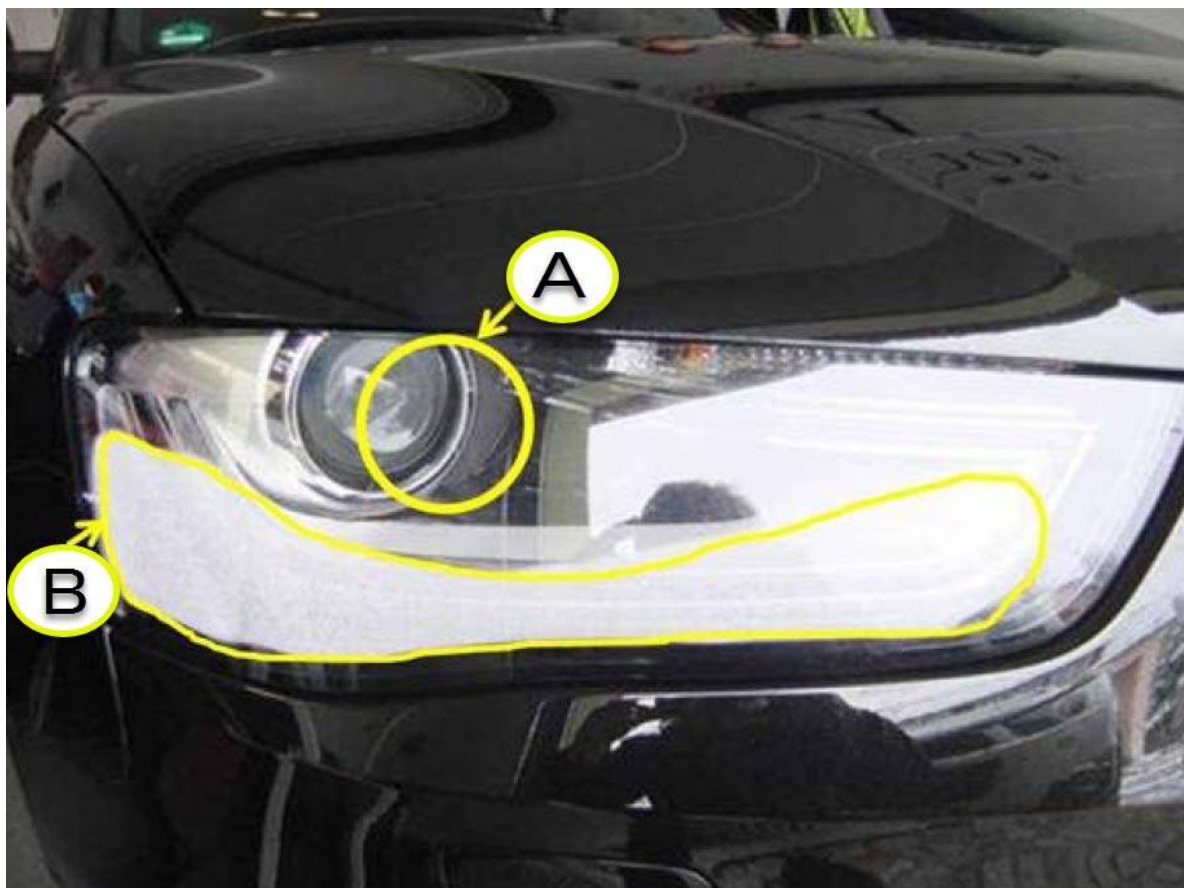
1. The light emission surface (Figure 2A) of the main beam should be clear after driving 10 minutes with the main beam on.
 - Driving speeds must be consistently over 45mph for the ventilation system to properly function.
 - Residual condensation (Figure 2B) maybe present depending on ambient conditions, this is normal.

Figure 2. A: main beam light emission surface. B: Condensation of the headlamp.

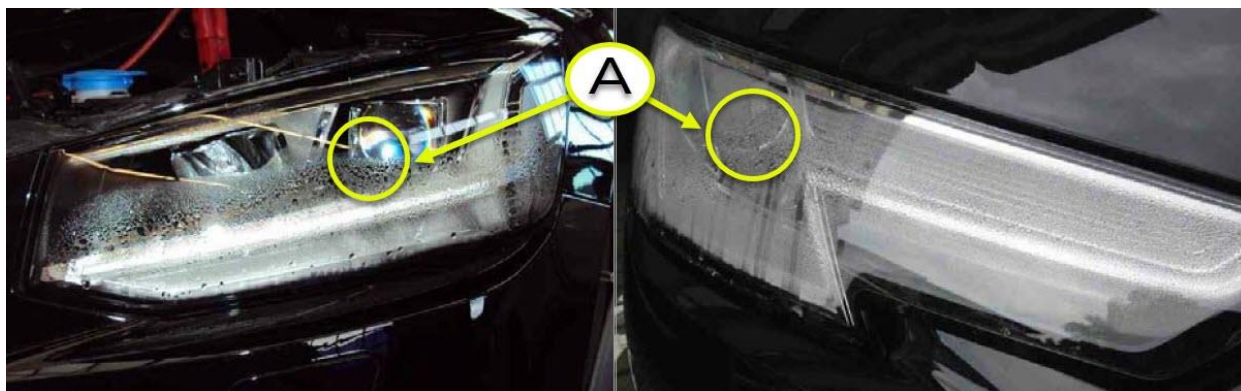
2. If water drops or condensation are present on the light emission surface (Figure 3A) after performing step one, inspect the headlamp assembly for the root cause.
 - Missing Cover
 - Damaged Seal
 - Clogged Drain
 - Outside influence

Figure 3. A: main beam light emission surface.

3. Perform repair:

- In cases where the headlamp assembly is not the root cause (clogged drain and/or missing access cover), dry the headlamp assembly with compressed air.
- Perform visual inspection of electrical connectors and any control modules attached to the headlight. If corrosion is found in one of these components, it must be repaired or replaced. Reference the repair manual for repair instructions.
