Technical Service Bulletin

94 High beam inoperative

94 17 89 2036670/3 July 24, 2017. Supersedes Technical Service Bulletin Group 94 number 14-58 dated December 10, 2014 for reasons listed below.

Model(s)	Year	VIN Range	Vehicle-Specific Equipment
Q5	2013 - 2017	All	Not Applicable

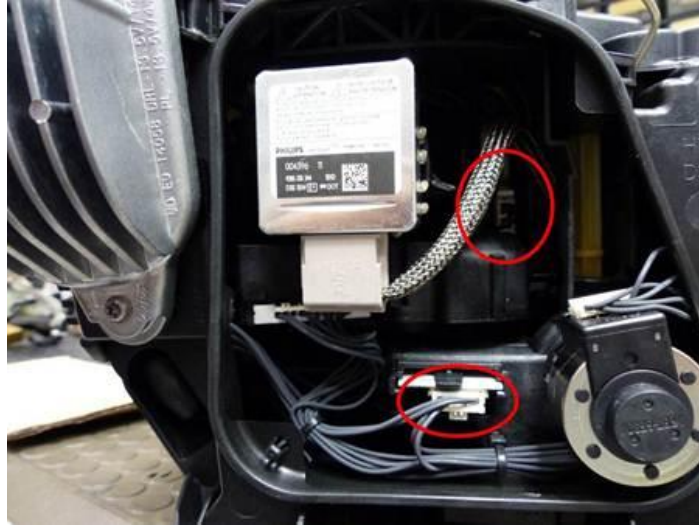
The connection for the high beam shutter is not connected in the affected headlight.

Figure 1. Connectors to be checked.

1. Remove the affected headlight and open the service cap.
2. Check the connectors (Figure 1) to see if they are securely connected.

3. If any connector is loose, inspect it for damage. If no damage is found, re-secure the connector. If it cannot be re-secured, replace the headlight.

When re-securing the connection, do not use a screwdriver or other metal object.

4. Re-connect the headlight and check the repair:
 - If the concern is no longer present, re-install the bumper cover, adjust the headlight(s), and complete GFF.
 - If the concern is still present, continue with diagnosis.
