Technical Service Bulletin

01 Coolant loss from coolant valve, engine warning light on, "Limp Home" mode active, cabin heating is insufficient

01 16 80 2033806/8 October 13, 2016. Supersedes Technical Service Bulletin Group 01 number 15-31 dated July 21, 2015 for reasons listed below.

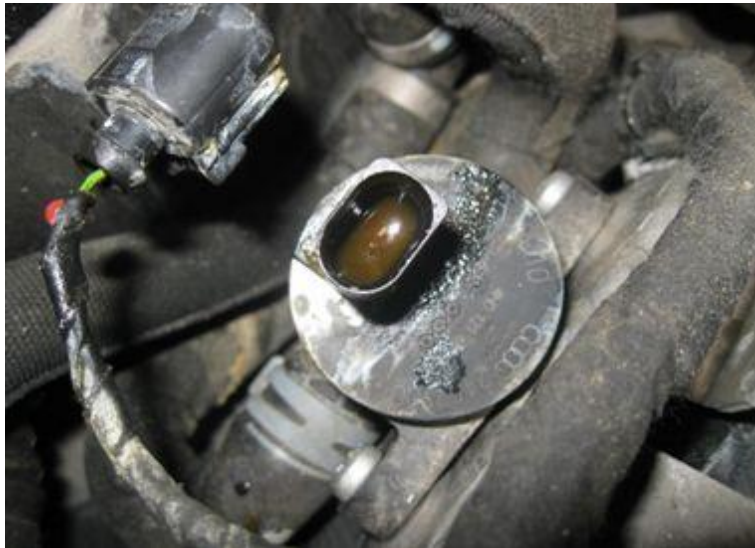
Inspection of the coolant control valves N82, N509, or N488 reveals the presence of coolant inside the electrical connector as shown in the illustration (Figure 1).

Figure 1. Coolant residue in the connector housing of the coolant regulating valve.

1. Diagnose the defective coolant valve (N82, N509, or N488) using Guided Fault Finding (GFF) where stored DTCs are found.
2. Replace the defective coolant valve.

Tip: Check the connectors, wiring harness, and connected control units for coolant damage. Perform repairs as necessary.

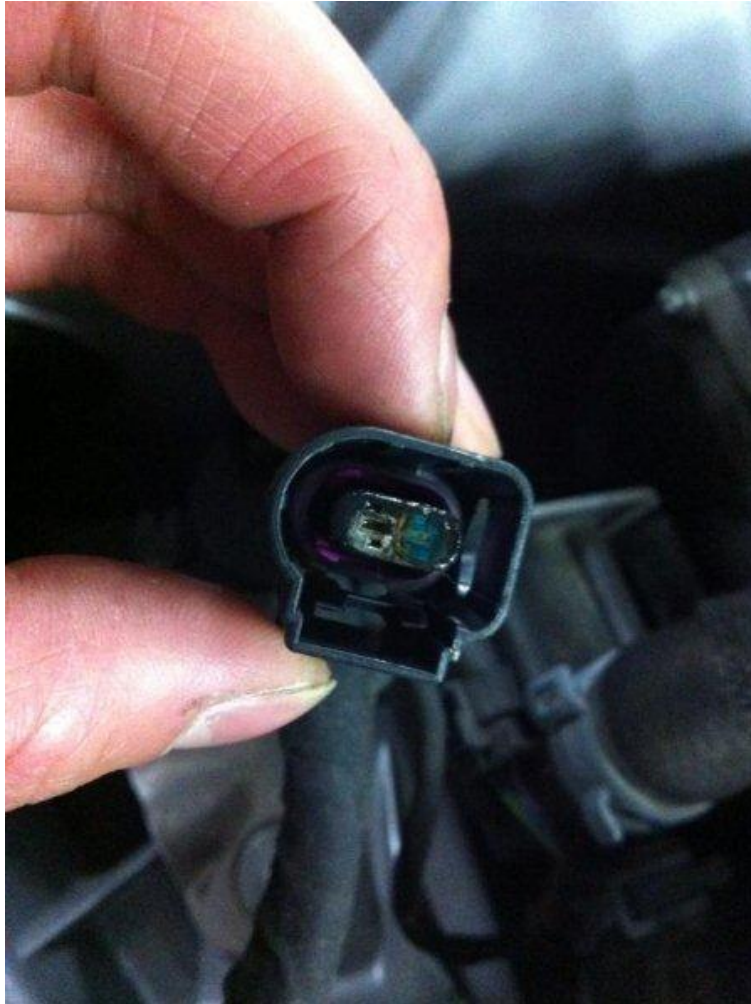
The connectors, wiring harness, and/or connected control units may have been damaged from exposure to coolant (Figure 2).

Figure 2. Corrosion formation on the connector pins.
