Technical Service Bulletin

61 Water leak at front corners of convertible top

61 16 26 2024108/6 October 25, 2016. Supersedes Technical Service Bulletin Group 61 number 16-25 dated August 12, 2016 for reasons listed below.

Model(s)	Year	VIN Range	Vehicle-Specific Equipment
A5 Cabriolet	2010 - 2017	All	Not Applicable

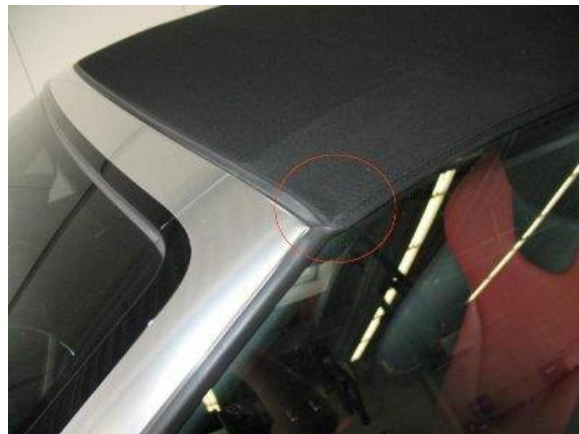
After heavy rain, water can migrate beyond the front convertible top header seal in the area where the convertible top header meets the windshield. The leak may not be immediately noticeable, but after a period of time following strong rainfall, the leaks can become evident in the front corners (Figure 1 and Figure 2).

Figure 1. Location where a leak may occur.

A section of butyl cord is installed in the roof frame seal (header) to close the path of water migration.

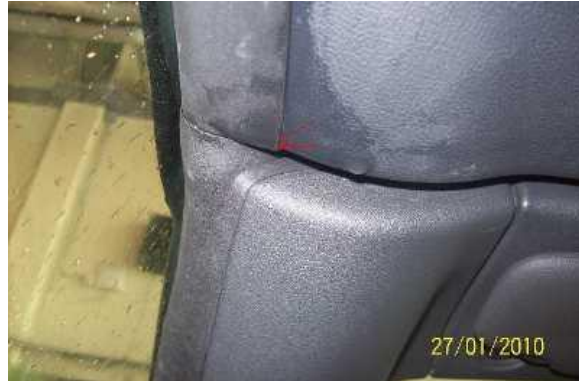
Figure 2. Evidence of a leak.

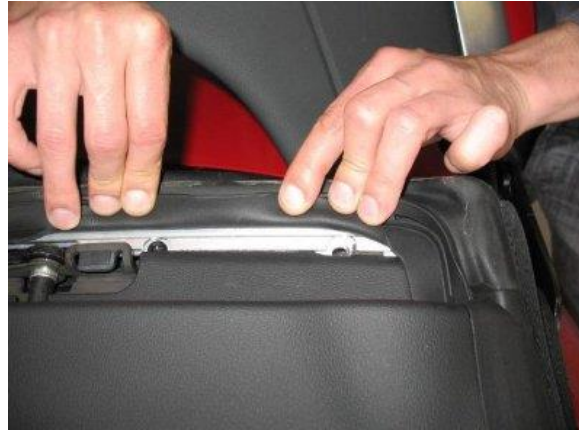
Figure 3. Folding back the seal bar.

3. Fold back the seal lip and loosen the bolts for the retaining strip (Figure 3).

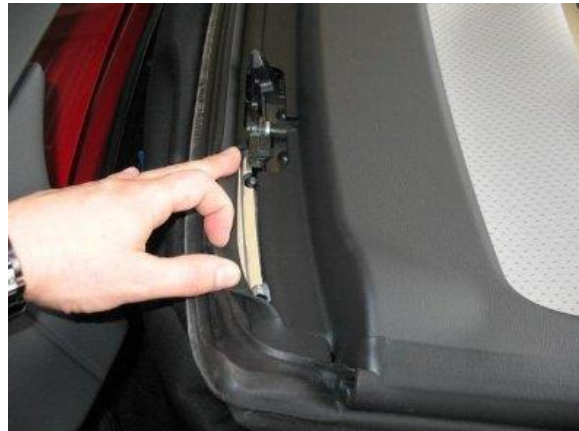
Figure 4. Lifting the corner.

4. Remove the bolts securing the retaining strip (Figure 4).

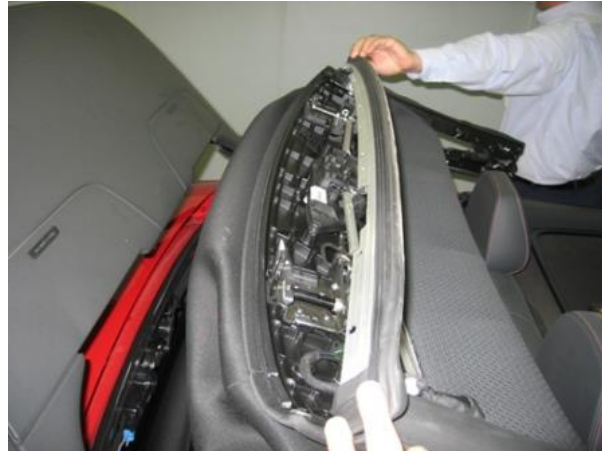
Figure 5. Retaining strip and seal pulled back.

5. Lift the retaining strip and seal away from the top cover (Figure 5).

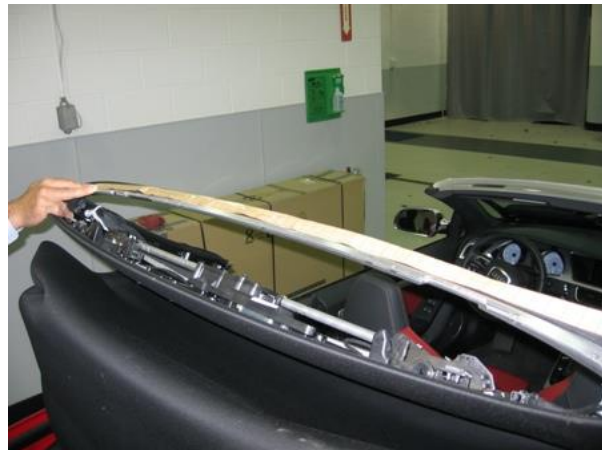
Figure 6. Butyl cord application.

6. Install a section of butyl cord (part number AKL45000505) between the seal and the top cloth across the front and into the corners. The section will be approximately 135 cm long (Figure 6).

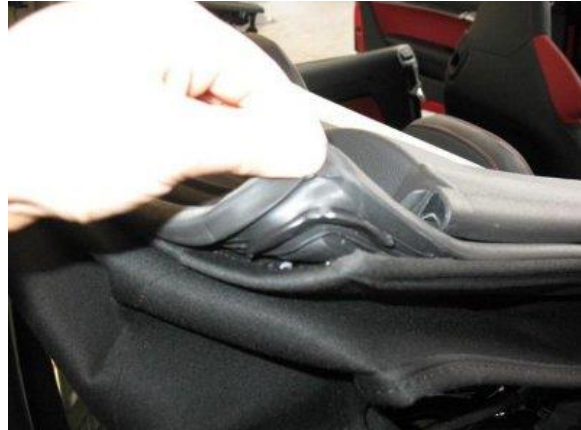
Figure 7. Pushing excess butyl cord into the end chambers.

7. Install a length of cord long enough to wrap around and past the corners, and extend 40 mm past the roof line. Make sure that the butyl cord is evenly spread between both edges in the outer groove of the seal. Kneading the cord may ease installation. Push any excess into the end chambers (Figure 7).

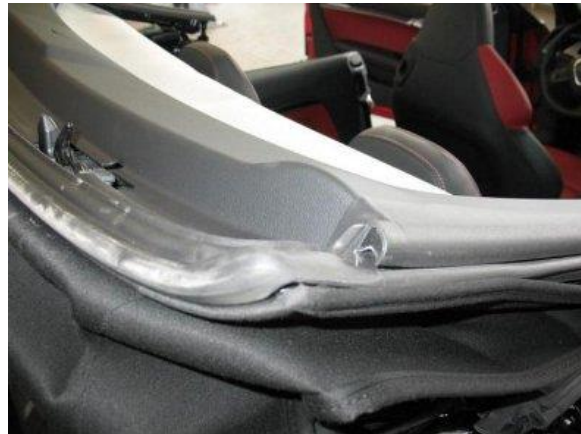
Figure 8. The seal, correctly positioned.

8. Press the seal on the cover and press firmly to ensure a good seal. Make sure the seal is correctly positioned on the cover (Figure 8).
