Technical Service Bulletin

91 MMI3G+ Google Earth does not load after K0942 MMI software update

91 16 77 2044940/2 October 3, 2016. Supersedes Technical Service Bulletin Group 91 number 16-61 dated July 22, 2016 for reasons listed below.

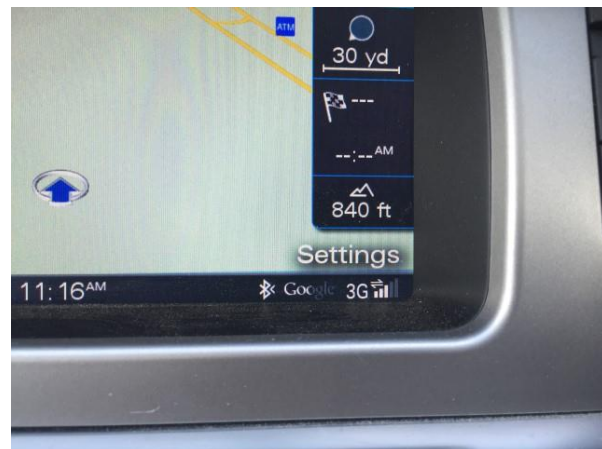
- The customer complains that Google Earth does not load in the MMI navigation map display.
- The Google icon only loads halfway and then freezes (Figure 1).

Figure 1. Google icon loads only halfway.

There is a known concern with the K0942 software update that can cause this issue. The final step of any MMI software update (ZUG update) is to document the location of where the MMI should store the customer data on the internal hard drive. The location for the Google Earth view data was incorrectly documented in this last step and created a condition where the MMI cannot store the data on the hard drive.

A software script (patch) has been developed to fix this concern and can be installed directly in the MMI via SD card. This script runs automatically and is not a ZUG update. Applying the patch does not require an ODIS tester. Only a blank SD card is required (1GB capacity is sufficient).

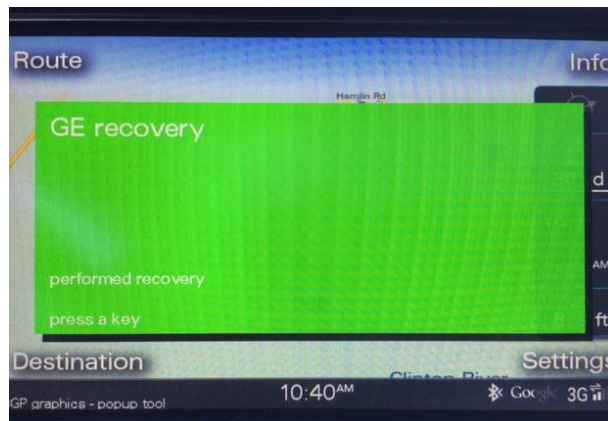
Figure 3. Confirmation screen for script

6. Once the script is complete, a green confirmation screen indicating that the script has been completed will be displayed (Figure 3). If the green confirmation screen is not displayed, check the SD card to ensure that it is not damaged. Additionally, recheck the location of the file on the SD card using a computer. Repeat steps 1-3 if needed.
