Technical Service Bulletin

91 Audi connect GEN2: Vehicle Code Entry Fails for Key User Setup or RLU, Veh. Status, Warning Messages Fail to Update

91 16 79 2045540/1 October 5, 2016.

Model(s)	Year	VIN Range	Vehicle-Specific Equipment
A4, Q7	2016 - 2019	All	With Audi connect

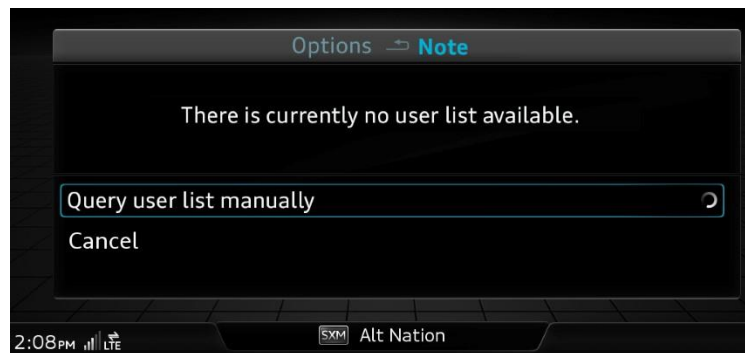
- The customer sees the warning message “There is currently no user list available” (Figure 1) when accessing the Audi connect user management screen in the MMI and cannot enter the vehicle code to become key user.

Figure 1. Warning message.

The customer complaint is created when the connected gateway logs off the mobile data network due to a known software concern. When this occurs, the connected gateway cannot communicate with the Audi connect backend server (MBB) despite the car being parked in an area where the mobile data network provides a strong signal. This can be a static condition that does not change when cycling the ignition nor when allowing the vehicle to go through a sleep cycle.

The connected gateway will need to be reset and the customer's vehicle code and myAudi user name will need to be used to setup the Key User if the customer is not already Key User. Replacing the connected data bus diagnostic interface (J533) (address word 19) will not resolve the condition. Service software is being prepared.

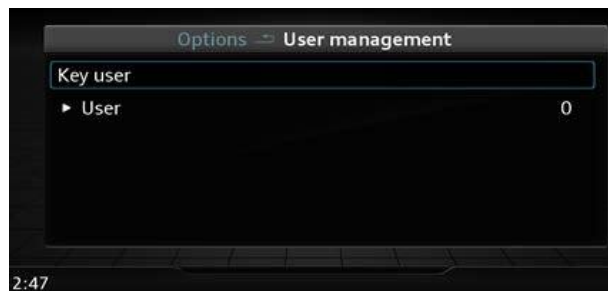
Figure 2. User management menu.

2. Switch the ignition off.
3. Reset terminal 30 (battery connection) for at least 30 minutes.
4. Reconnect the battery and switch on the ignition and wait at least 1-2 minutes until the MMI has fully loaded.
5. Then go to the Audi connect user management screen by navigating to: *MENU >> Audi connect >> Right option >> Audi connect user management.*
6. Select “Key user” (Figure 2). If the customer’s user name is already entered in the MMI then step 7- 8 can be skipped. Proceed to step 9.

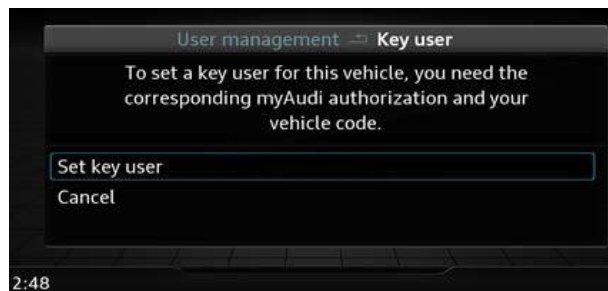
Figure 3. Set key user.

7. Select “Set key user” (Figure 3).

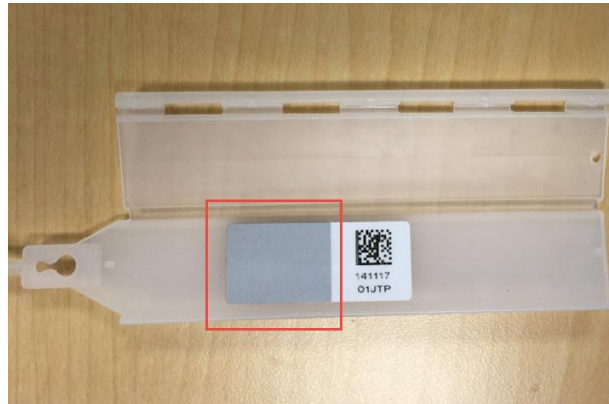
Figure 4. Vehicle code (F-PIN)

8. Enter the customer's vehicle code (Figure 4) and myAudi user name (email address) and select "Log in" (Figure 5).

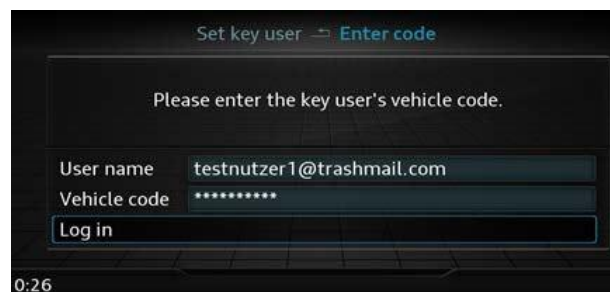
Figure 5. Log in.
