Technical Service Bulletin

19 Heating output insufficient (DTC B10D004 and/or B11D501)

19 17 81 2047114/2 March 15, 2017. Supersedes Technical Service Bulletin Group 19 number 17-80 dated March 9, 2017 for reasons listed below.

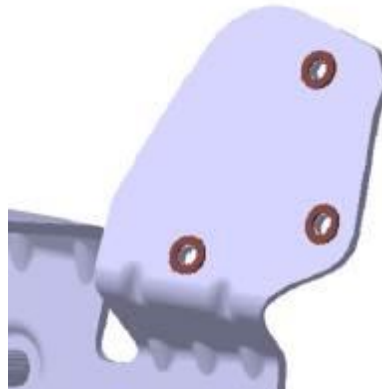
Figure 1. Washers installed.

To ensure about 1mm distance between the V50 coolant recirculation pump and its bracket (Figure 1 and 2):

Replace the V50 coolant recirculation pump, use the washers if pump is mounted with screws to the bracket as shown (some models have rubber covered metal band instead).

- N 011 523 21 (3x)

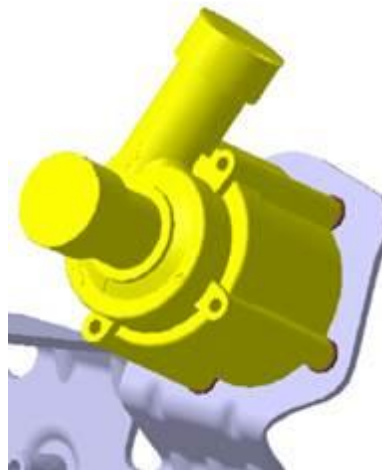
Figure 2. Pump mounted.
