Technical Service Bulletin

PSS 91 MMI screen goes blank after iPhone is connected to USB port

91 17 13 2044130/4 March 10, 2017. Supersedes Technical Service Bulletin Group 91 number 16-62 dated July 26, 2016 for reasons listed below.

Model(s)	Year	VIN Range	Vehicle-Specific Equipment
A4	2016 - 2017	000001 - 047433	Audi smartphone interface
Q7	2017	000001 - 047433	Audi smartphone interface

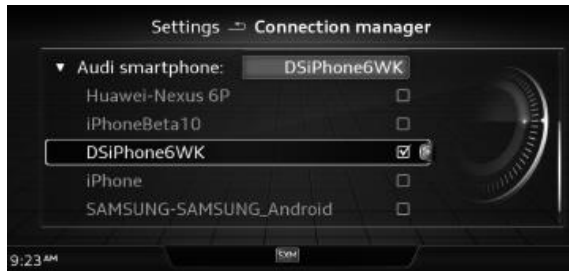
Figure 1. iPhone is selected for ASI (CarPlay).

3. Create a PSS record in the PSS application through the Pending Service Solutions (PSS) link in AccessAudi (under *App Links>>Service>>Pending Service Solutions (PSS)*), or through the Technical Assistance page in Elsa.
4. As a temporary workaround, ask the customer to:
 - **If the screen goes blank when CarPlay is accessed immediately after the car is started or if the screen flashes back to the MMI menu after selecting CarPlay:** connect the iPhone after the car is started and while the transmission is still in the park position. If the customer gets into this condition they can fix the concern by going to the connection manager (Figure 1) and deselecting the iPhone (Figure 2) and reselecting under Audi Smartphone Interface (*Settings>>Connection Manager>>Audi Smartphone Interface; Figure 1*). This will force the MMI to start a new CarPlay session with the iPhone.

- **If the screen flashes when selecting CarPlay after using the backup camera:** inform the customer there is no current workaround. If the customer has this issue they can temporarily fix the concern by going to the connection manager (Figure 1) and deselecting the iPhone (Figure 2) and reselecting under Audi Smartphone Interface (*Settings>>Connection Manager>>Audi Smartphone Interface*; Figure 1). This will force the MMI to start a new CarPlay session with the iPhone.

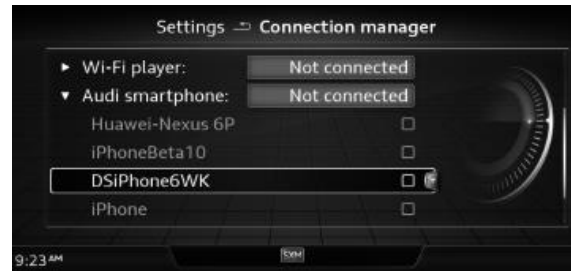
Figure 2. iPhone is no longer selected for ASI (CarPlay).
