Technical Service Bulletin

01 MIL on (DTC P0491/P0492 Secondary Air Injection System Bank 1/2 Insufficient Flow)

01 17 10 2035002/5 April 20, 2017. Supersedes Technical Service Bulletin Group 01 number 16-55 dated March 14, 2016 for reasons listed below.

Model(s)	Year	VIN Range	Vehicle-Specific Equipment
A8	2010 - 2012	All	4.2FSI

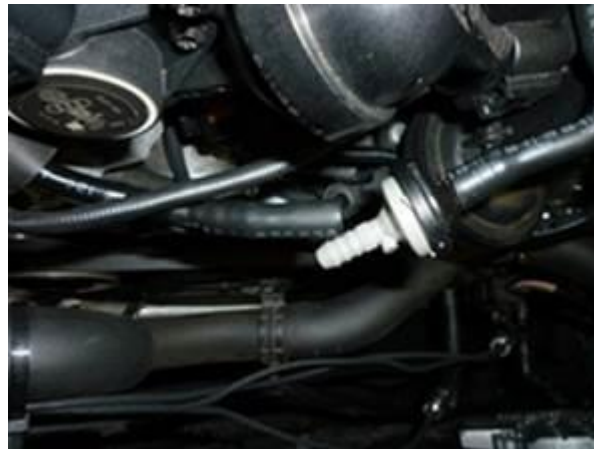
Figure 1. Vacuum check valve.

1. Check the vacuum check valve for leaks (Figure 1). The direction of flow should only be towards the intake manifold.

If a leak is found at the check valve, replace the valve and recheck.

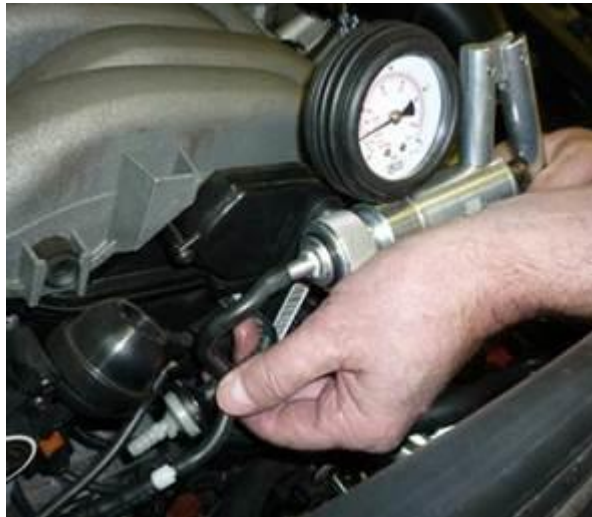
Figure 2. VAS 6213 hand vacuum pump.

2. With the hose to the check valve disconnected, apply 400 mmHG of vacuum with the VAS 6213 hand vacuum pump (Figure 2).

If the vacuum supply drops during the first 10 minutes of the test, check the complete vacuum system and solenoid changeover valves for leaks using the diagram below.

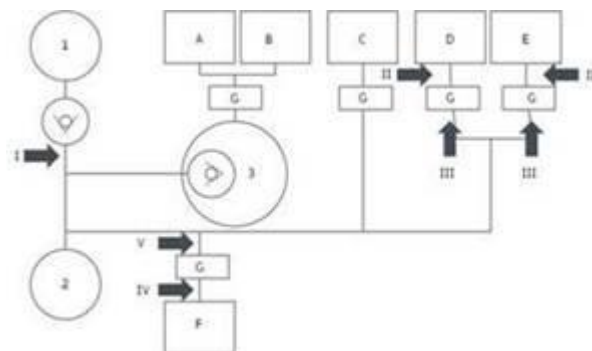
Figure 3. Vacuum Diagram

See diagram (Figure 3):

Repair as necessary.
