Technical Service Bulletin

48 Creaking or squeaking noises from steering column (sealing boot)

48 17 72 2034351/7 April 12, 2017. Supersedes Technical Service Bulletin Group 48 number 16-69 dated March 18, 2016 for reasons listed below.

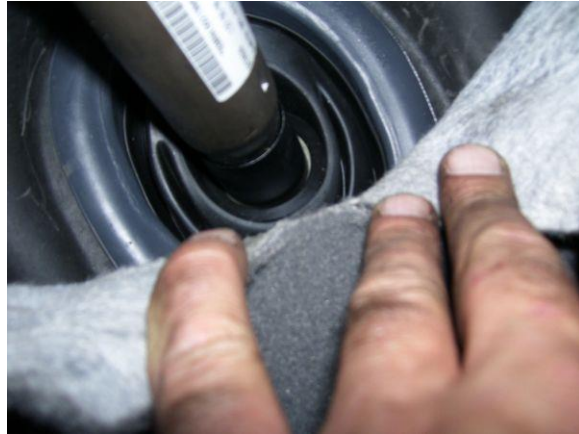
The noise comes from the sealing sleeve/steering column opening on the bulkhead. For an example of the noise, listen to the audio file at <https://audi-external.kzoplatform.com:443/swf/player/304> (Figure 1).

Insufficient lubrication of the intermediate steering shaft in the area of the sealing sleeve.

Figure 1. Sealing sleeve on the bulkhead.

1. Check the sealing sleeve for proper installation and fit (Figure 1).

- To eliminate the noise, loosen the upper bolted connection of the steering intermediate shaft and the steering column. Pull the intermediate steering shaft out about 4 in (10 cm) and spray the special lubricant spray (**G052172M2**) in the area of the bearing ring and the black plastic sleeve. Push it in and pull it out a few times to distribute the spray on the intermediate steering shaft.

Do not lubricate the u-joints of the steering shaft.

- Retighten the shaft with a new bolt on the steering column.
- If the noise persists, replace the intermediate steering shaft.
