Technical Service Bulletin

91 MIB2 High: iPod Classic is not recognized when connected to MMI via USB

91 17 29 2047965/1 May 25, 2017.

Model(s)	Year	VIN Range	Vehicle-Specific Equipment
A5, A5 cabriolet, S5, A6, A7, A8, TT, Q3, Q5, SQ5, Q7, R8	2017 - 2020	All	MIB2 High Navigation

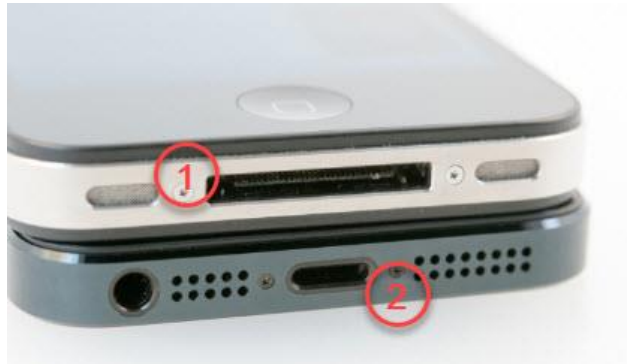
The customer states that the iPod or iPhone is not recognized by the MMI when connected to the Audi Music Interface over USB. The MMI will show a greyed out message of "Not compatible". The customer's Apple device has a 30-pin dock connector (Figure 1). The vehicle has MIB2 MMI hardware with Navigation.

Figure 1. (1) 30-pin dock connector; (2) 9-pin lightning connector

Since the introduction of the new MIB2 MMI hardware architecture starting with vehicles built on or after CW45/16 (CW52/16 for MY18 Q5), the Apple iPod Accessory Protocol 1 is no longer supported (iAP1). The only MMI supported Apple devices are the devices with a 9-pin lightning connector (Figure 1) which support the Apple iPod Accessory Protocol 2 (iAP2).

Explain to the customer the information in the Technical Background. Using a 30-pin to 9-pin Lightning adapter will not resolve the concern. There is no work around for this concern due to the issue with the older devices not being able to support the iAP2 protocol. The MMI can only support the iAP2 protocol for devices with a lightning connector.
