# Technical Service Bulletin

## 40 Protective sleeve for shock absorber, noises from front end when steering or during spring movement

40 17 64 2047759/1 May 18, 2017.

Model(s)	Year	VIN Range	Vehicle-Specific Equipment
A3, S3	2015 - 2017	All	Not Applicable
TT	2016 -2017	All	Not Applicable

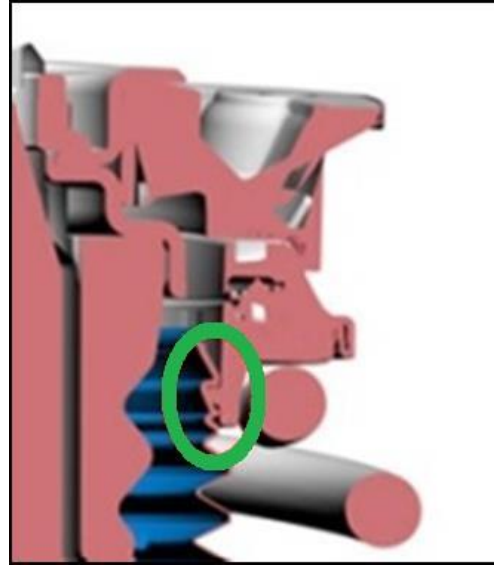
The correct positioning of the protective sleeve (Figure 1, green ellipse).

**Figure 1.** Correct positioning of protective sleeve.

If the protective sleeve is not correctly positioned, unclip it completely before fixing it.

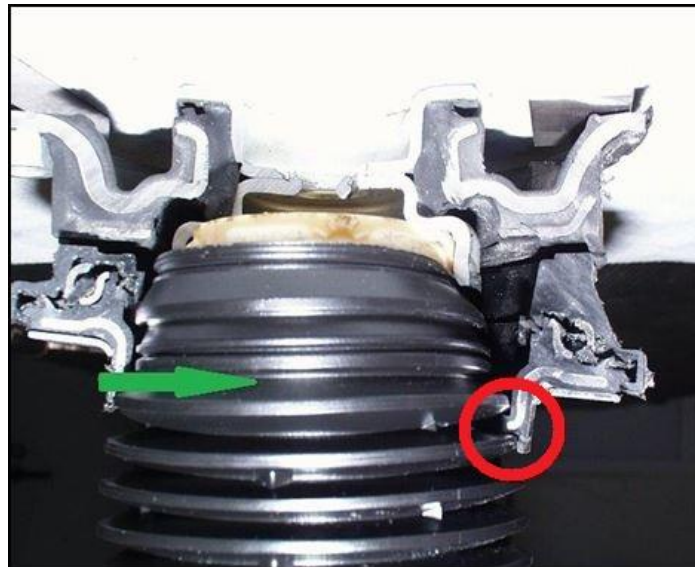
An incorrectly fitted protective sleeve (Figure 2, red circle). The protective sleeve was pushed too deeply into the deep groove ball thrust bearing, so that the wrong groove was used (Figure 2, green arrow).

**Figure 2.** Incorrectly positioned sleeve.

If the protective sleeve of the shock absorber is damaged or deformed, it must be replaced.
