# Technical Service Bulletin

## 01 Coolant loss from coolant valve, engine warning light on, "Limp Home" mode active, cabin heating is insufficient

01 15 31 2033806/7 July 21, 2015. Supersedes Technical Service Bulletin Group 80 number 14-07 dated August 11, 2014 for reasons listed below.

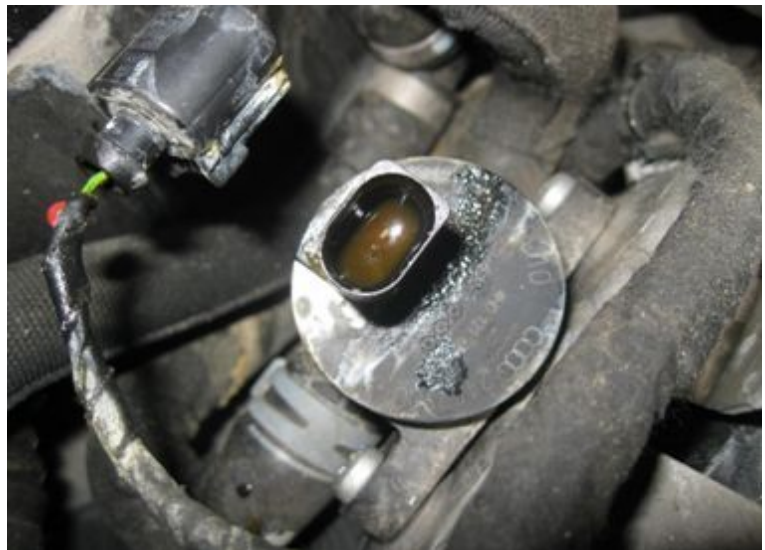
Inspection of the coolant control valves N82, N509, or N488 reveals the presence of coolant inside the electrical connector as shown in the illustration (Figure 1).

**Figure 1.** Coolant residue in the connector housing of the coolant regulating valve.

1. Diagnose the defective coolant valve (N82, N509, or N488) using Guided Fault Finding (GFF) where stored DTCs are found.
2. Replace the defective coolant valve.

**Tip:** Check the connectors, wiring harness, and connected control units for coolant damage. Perform repairs as necessary.

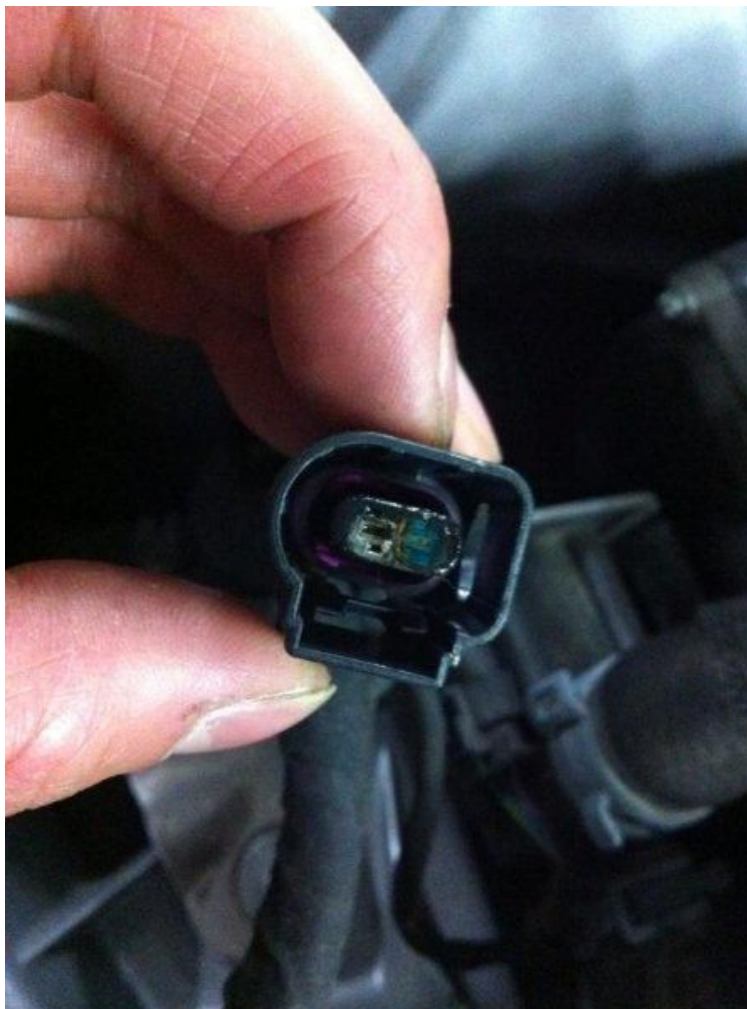
The connectors, wiring harness, and/or connected control units may have been damaged from exposure to coolant (Figure 2).

*Figure 2. Corrosion formation on the connector pins.*
