Technical Bulletin

Model(s)	Year	Eng. Code	Trans. Code	VIN Range From	VIN Range To
Phaeton	2004 - 2006	All	All	All	All

57 16 06 June 13, 2016 2039003 Supersedes Technical Bulletin V571502 dated July 20, 2015 to update Claim Processing statement.

Corrosion on Front Doors (Multiple Locations)

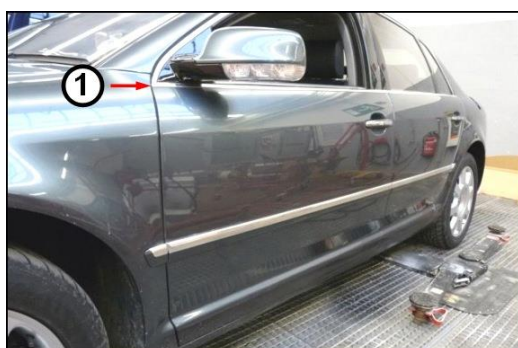
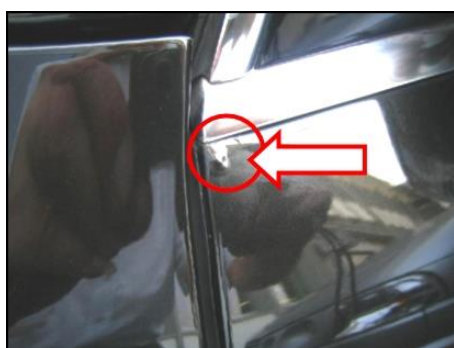
Figure 1 – Upper window channel strip

Figure 1.1

Alignments in production can lead to hairline cracks in the top coat and paint damage (edges on holes) on the already painted door. Humidity then penetrates paint and causes blistering and/or white corrosion.

- Inspect the inner edge area of the doors for cracks, particularly the fine seam sealing.
- Completely remove the corrosion in the damaged area.
- Apply a VOC compliant epoxy primer as an anti-corrosion treatment and primer to both sides of the door (locally sourced).
- Seal the edges/metal sheathings with adhesive (part number: AKD 476 KD505) before painting.
- Repaint door according to Volkswagen guidelines

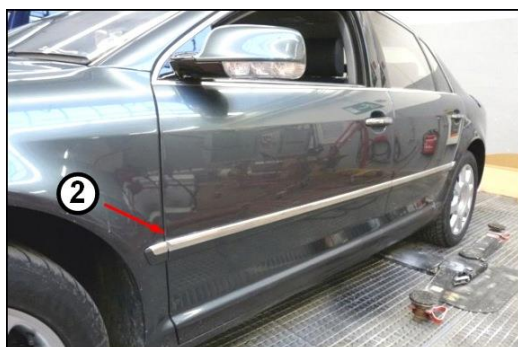
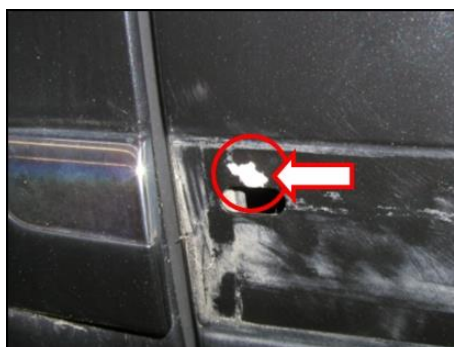
Figure 2 – Central protective strip

Figure 2.1

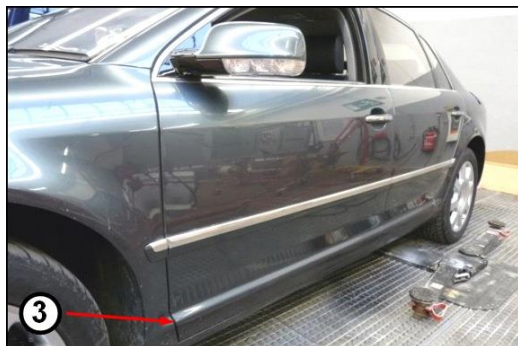
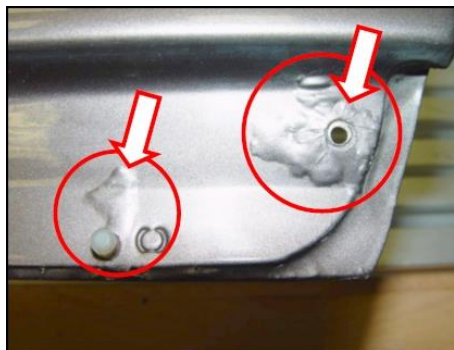
Figure 3 – Lower protective strip

Figure 3.1

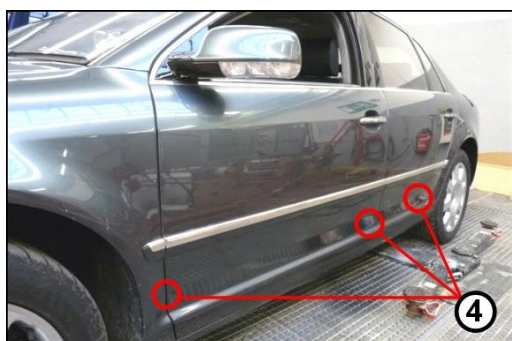
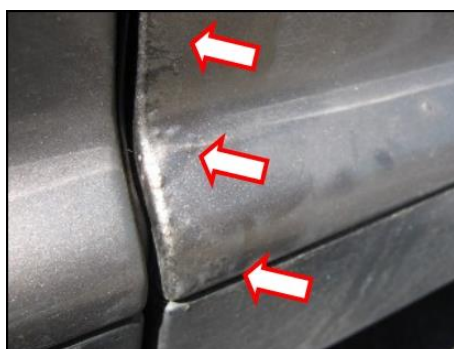
Figure 4 – Surface/edge corrosion

Figure 4.1

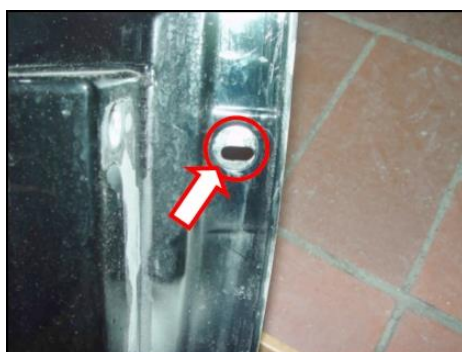
Figure 5

Inner door area (Figure 5 and 6).

Holes and edges in the flange area.

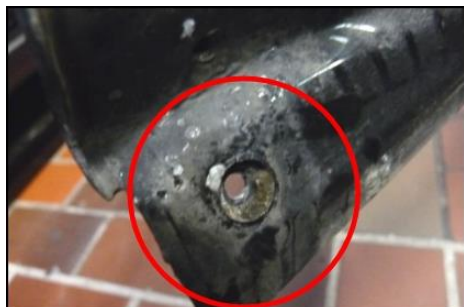
Figure 6 (front door, lower left)
