Technical Bulletin

55 16 12 June 9, 2016 2039446 Supersedes Technical Bulletin V551603 dated February 17, 2016 to update Claim Processing statement.

Corrosion Hood Edge

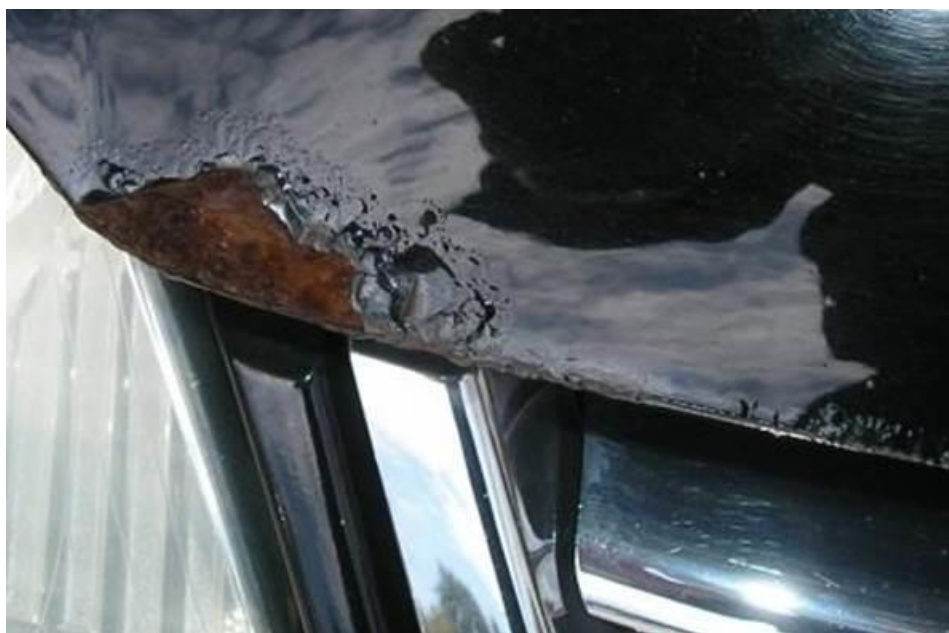
Corrosion may be found on the folded edge of the hood. The corrosion may be found on this edge anywhere around the hood.

- Remove the Hood from the vehicle. See Repair Group 55 in Elsa.
- Remove the corrosion with Pneumatic Brush Grinder Set -VAS6446 or similar tool.
- Sand the overlapping areas with P360 - P400 sandpaper.

- Clean the base surface with a VOC compliant cleaning solution.
- After a corrosion repair and before sealing, insulate the base surface with a Two-Part Wash Primer and then fill with Two-Part HS Performance Filler. (Both Locally Sourced).

- After the filler has dried, the filled area must be dry sanded with P400- P500. While doing so, make sure to avoid "sanding through". Then clean the sanded areas with a VOC compliant cleaning solution.

- After the filler has dried and has been sanded, the metal edges in the fold area must be thinly sealed with Polyurethane adhesive -AKD 476 KD5 05.
- Paint the hood according to Volkswagen specifications.
