# Technical Bulletin

Model(s)	Year	Eng. Code	Trans. Code	VIN Range From	VIN Range To
Phaeton	2004 –2006	All	All	All	All

58 16 02 June 13, 2016 2039211 Supersedes Technical Bulletin V581502 dated July 21, 2015 to update Claim Processing statement.

### Corrosion on Rear Doors (Multiple Locations)

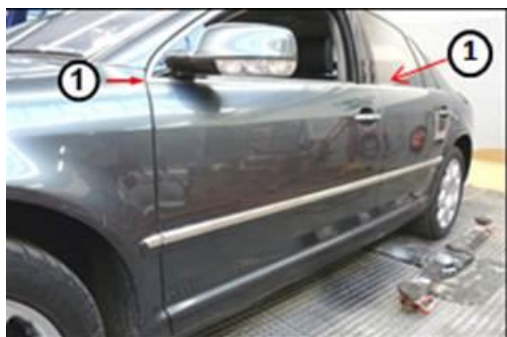
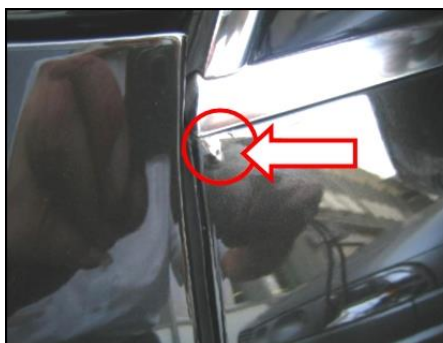
Figure 1 – Upper window channel strip

Alignments in production can lead to hairline cracks in the top coat and paint damage (edges on holes) on the already painted door. Humidity then penetrates paint and causes blistering and/or white corrosion.

- Inspect the inner edge area of the doors for cracks, particularly the fine seam sealing.
- Completely remove the corrosion in the damaged area.
- Apply a VOC compliant epoxy primer as an anti-corrosion treatment and primer to both sides of the door (locally sourced).
- Seal the edges/metal sheathings with adhesive (part number: AKD 476 KD505) before painting.
- Repaint door according to Volkswagen guidelines

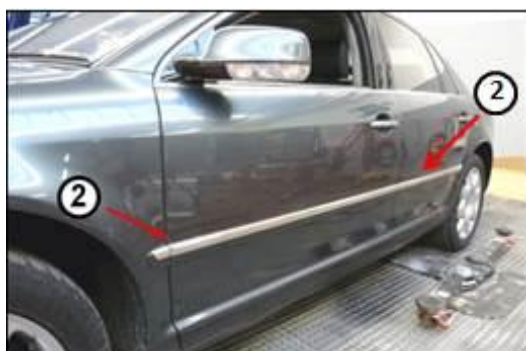
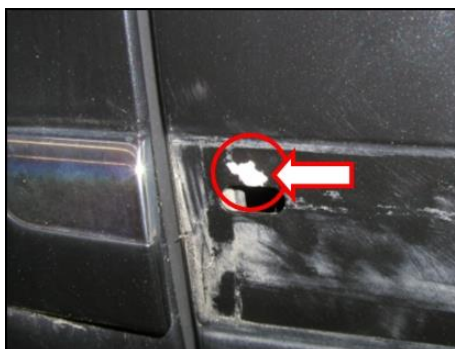
Figure 2 – Central protective strip

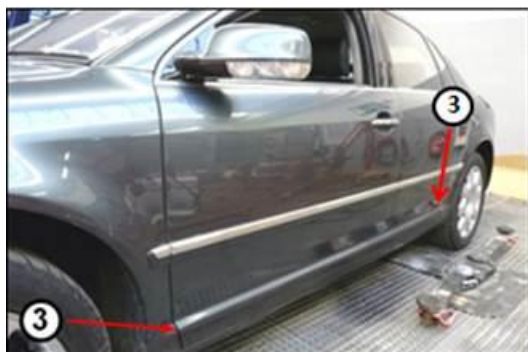
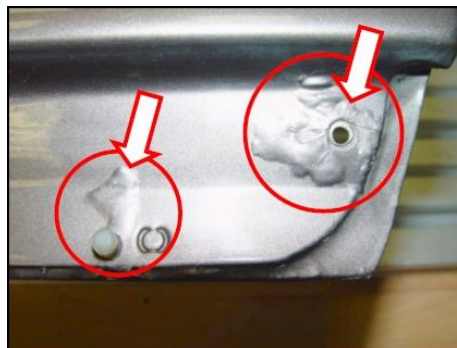
Figure 3 – Lower protective strip

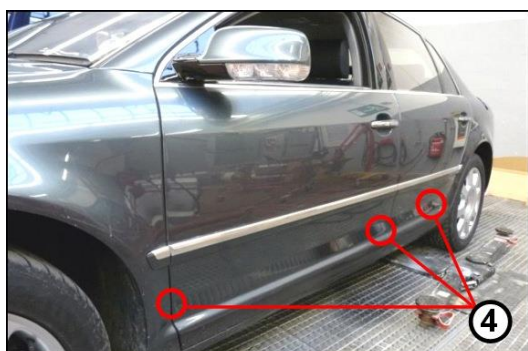
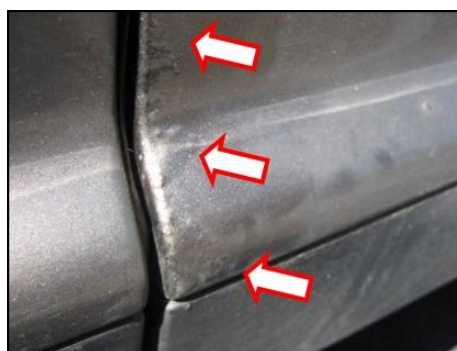
Figure 4 – Surface/edge corrosion

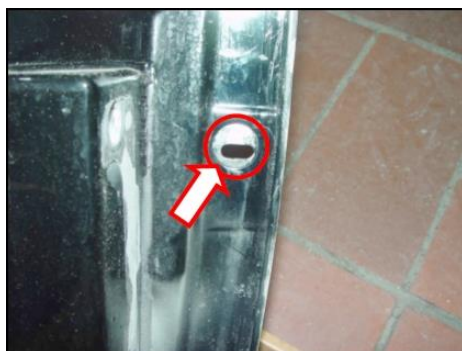
Figure 5

Holes and edges in the flange area
