SERVICE BULLETIN

Classification: EL15-006n	Reference: NTB15-049n	Date: January 4, 2018
------------------------------	--------------------------	--------------------------

TELEMATICS SERVICE INFORMATION

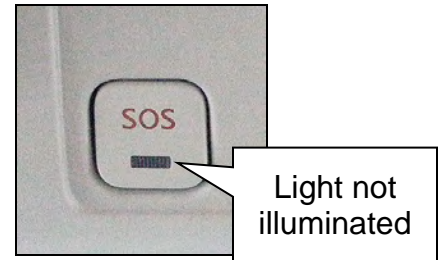
Figure 1a

1. With the vehicle in an area of known good reception, turn the ignition ON and check whether or not the green light on the SOS button is illuminated (see Figure 1a).

- If the green light **is** illuminated, the process to turn ON the TCU is complete and no further action is needed.
- If the green light **is not illuminated**, proceed to step 2.

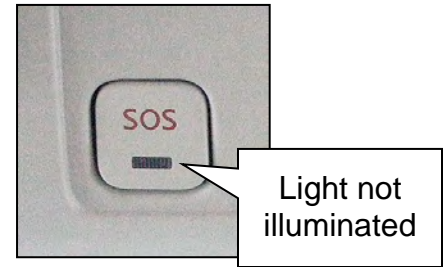
Vehicle is shown as not enrolled:

- The customer is not enrolled in NissanConnectSM Services. Have the customer enroll and confirm the SOS light illuminates.

“VIN not found” displays:

- The vehicle needs to be registered in the Nissan Owner Portal and enrolled in NissanConnectSM Services. Have the customer register and enroll and confirm the SOS light illuminates.

Vehicle is shown as enrolled:

- Confirm the customer’s NissanConnectSM Services subscription.

If the customer is enrolled in the Premium or Premium Plus Package, call TECH LINE for diagnosis.

If the customer is enrolled in the Select Package, the SOS light **is not intended to illuminate**. No further action is needed.
