## Technical Information Bulletin

**43-051**

2017 Emissions Under Frame (UNFR) Aftertreatment Back of Sleeper (BOS) Exhaust Pipe Drain Hole

1/9/2018

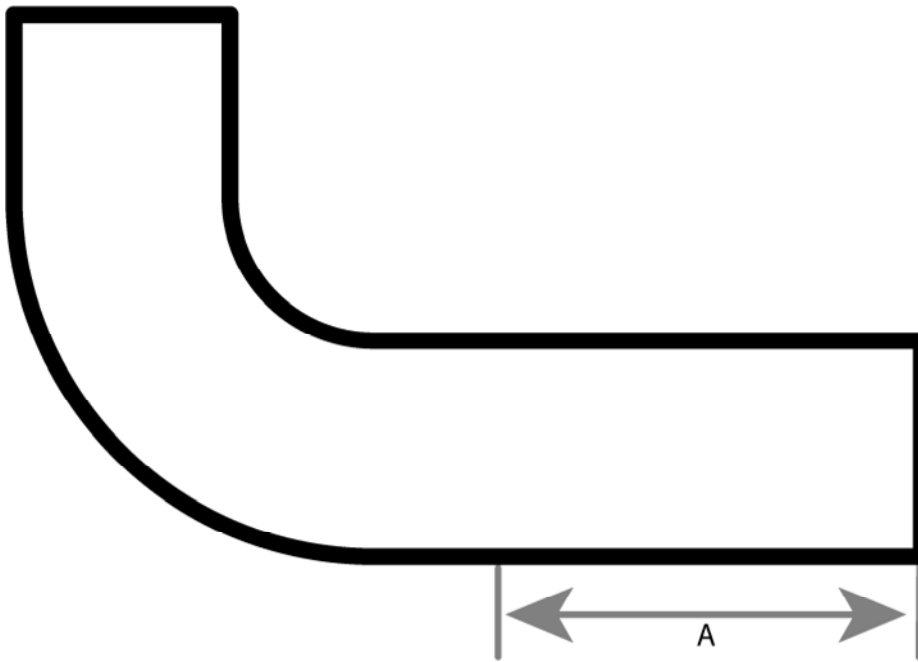
The lower elbow of the exhaust system does not have a drain hole, allowing water to collect in the pipes and backflow into the aftertreatment canister. Fault codes related to the NOx and SCR system may set, the NOx sensor may fail, and in extreme cases, the SCR may lose efficiency.

1. Use drawing number M97-6552 from WebEcat to locate the PIPE-EXH, BACK OF SLPR SCR elbow.
2. Locate and mark the bottom of the pipe at the point where it is closest to the ground. This point is expected to be at the approximate distance as shown in the following table and image.

Pipe Part Number	A (mm)
M66-6797-0245X0260	93
M66-6797-0245X0800	633
M66-6797-0245X0860	693
M66-6797-0245X0540	373

3. Remove the pipe and allow water to drain from the exhaust system.
4. Use a center punch to dimple the drilling point marked in Step 2, and then drill a ¼ in. hole through the pipe
5. Reinstall the pipe.
