No.: 14 TS-18 June 25, 2014

SUBJECT: GHG14 DD Engine EGR System Fault Codes

Note: This document supersedes 13 TS-30.

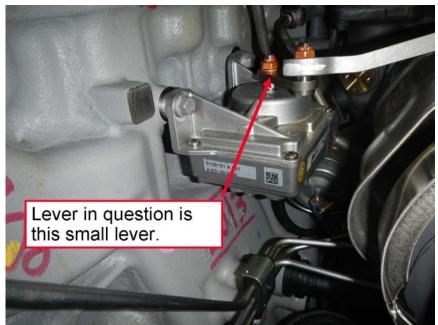
Figure 1 – Location of Lever

1. Carefully inspect the EGR valve system hardware consisting of the EGR valve actuator, lever, pull rod, and EGR valve for incorrect, missing, damaged, or loose parts. The lever on top of the EGR valve actuator is dependent on engine model and type. See Figures 1 and 2 for information on how to correctly identify the lever. Note the numbers stamped on the lever.

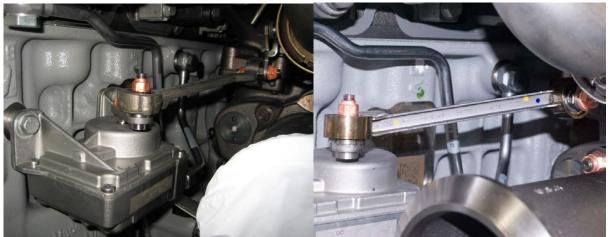
2. Inspect the pull rod connecting the lever to the EGR valve. The hardware should be firmly tightened with no slack, and there should be no binding in movement. The pull rod has a "v" stamped on it at the EGR valve end, and an "s" stamped on it at the EGR valve actuator end. The DD15AT (472906) has an additional spacer at the EGR valve end that must also be correctly installed. The spacer is used on the connecting bolt between the top of the pull rod ball socket and the bottom of the EGR valve circular lever. Omission of the spacer can result in binding of the EGR valve during actuation. The EGR pull rod lever design is different on DD13, DD15TC, and DD16 engines and a spacer is not used on those applications. See Figures 3-6 for examples of the various configurations.

Figure 3 – DD13 System, Pull Rod P/N Located on Top (Former) or on Front Facing Away from Engine (Current)

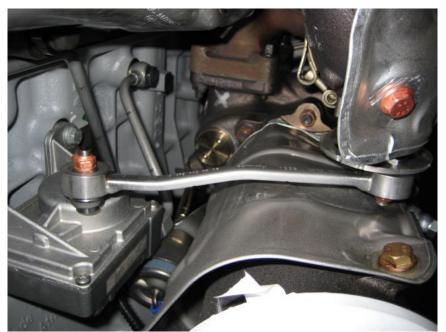
Figure 5 – DD15AT (472906) System, Pull rod P/N Located on Top

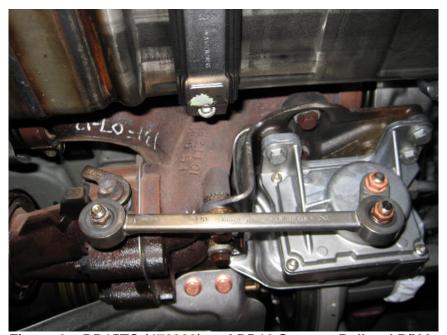
Figure 6 – DD15TC (472909) and DD16 System, Pull rod P/N Located on Top
