June 10, 2014

BTB 51670 (1406)

MIL Comes On With DTC P0101

AFFECTED VEHICLES

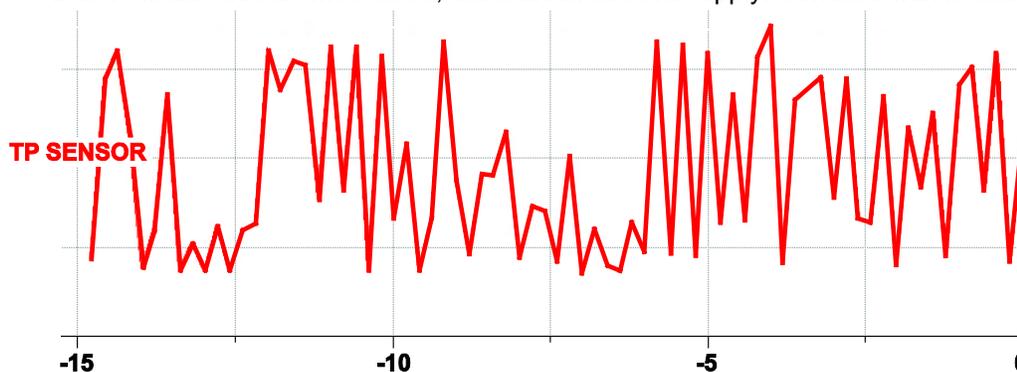
Does the data show the vehicle driving with constant throttle movement like the example shown below?

- If there is **constant throttle movement**, go to REPAIR PROCEDURE.
- If there is little throttle movement, this bulletin does not apply. Continue with normal troubleshooting.

Update the PGM-FI software. Refer to Service Bulletin 01-026, *Updating Control Units/Modules*.
