<b>Subject:</b> NAVIGATION SD CARD ERROR MESSAGE "Invalid SD Card"	<b>M-Tips No.:</b> MT-001/18
	<b>Last Issued:</b> 01/02/2018

## DESCRIPTION

When installing a navigation SD card, the center display may show error message "Invalid SD Card".

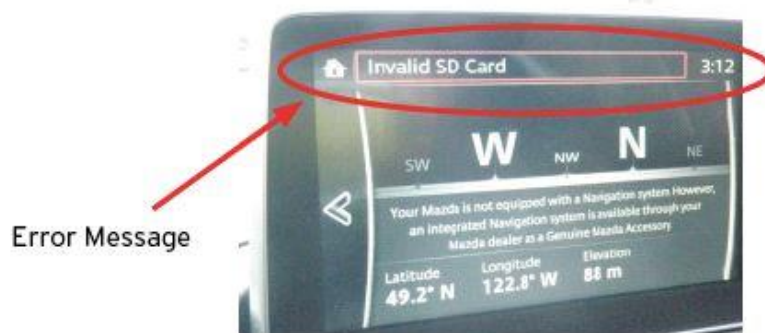
This may be caused by:

- The navigation SD card lock tab is locked.
- The navigation SD card has a VIN mismatch due to SD card swapping.
- The navigation SD card has a malfunction.

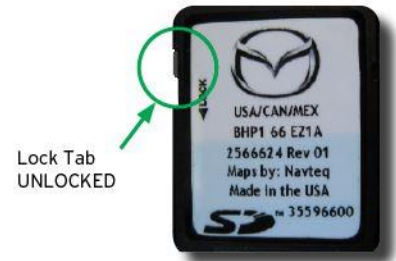
**SD Card Lock Tab**

1. Only insert or remove the SD card with the ignition switch OFF.
2. If the SD card is installed with the tab at the “LOCK” side, the navigation system will not operate.

Set lock tab to “UNLOCKED” position before inserting SD Card.

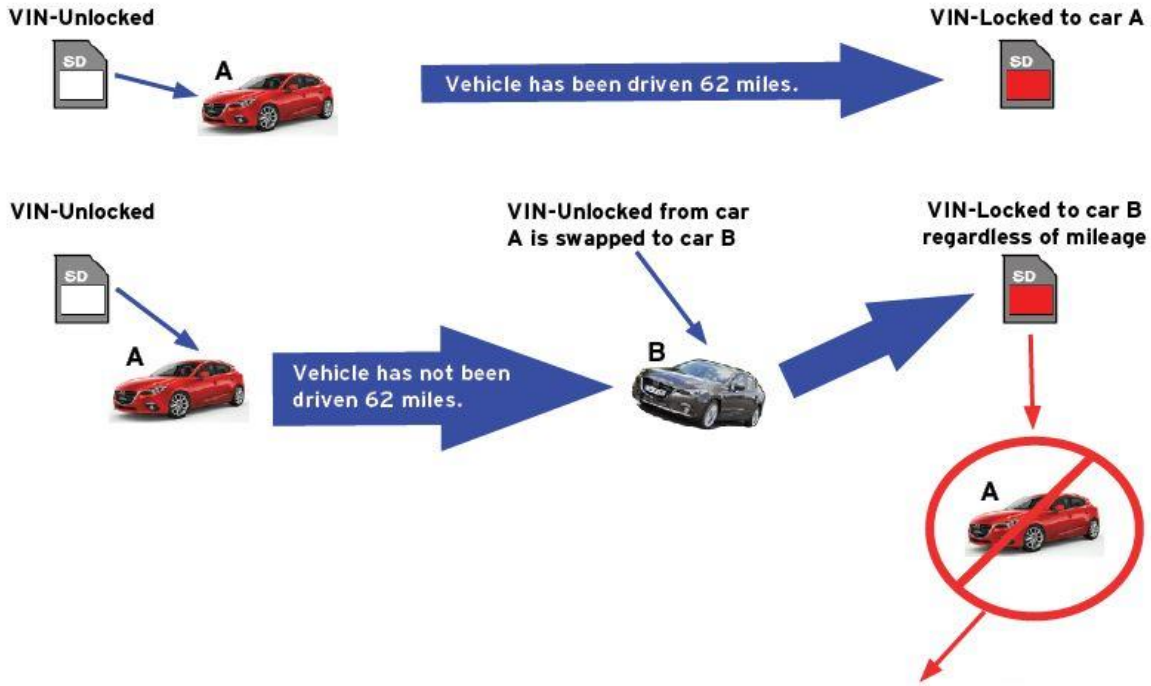
**SD Card VIN Mismatch**

**CAUTION: NEVER** swap the navigation system SD card from one vehicle to another for testing. If swapped, the SD card that is installed into the other vehicle may be “linked” to the VIN of that vehicle. The SD card is VIN-locked the instant the card is inserted into a vehicle with 62 miles or more.

If a SD card with VIN-locked condition is installed to another vehicle, there will be an error message “Invalid SD Card” on the center display.

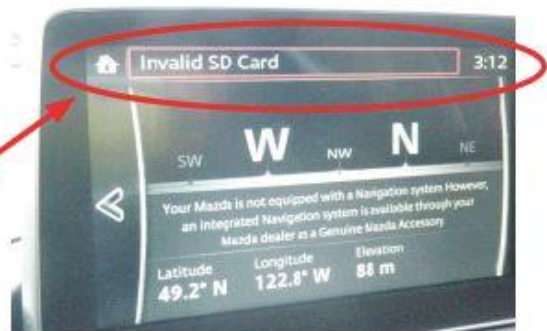
Error Message

1. Error message may be displayed when SD Card is updated or replaced. The error message “Invalid SD Card” is displayed on the center display when there is a malfunction (as mentioned previously, unauthorized modification, hard core failure etc.) with the SD card. This error message may also be displayed when the SD card is updated or replaced. The cause may be the CMU not reading the SD card. As a countermeasure, put the CMU into a sleeping condition using the following procedure.

Procedure to set CMU into sleeping condition	
1	Verify the error message.
2	Turn the ignition "OFF".
3	Exit the vehicle with key and lock the door.
4	Wait 5 minutes.
5	Turn the ignition to "ACC" and verify that the message is no longer displayed.

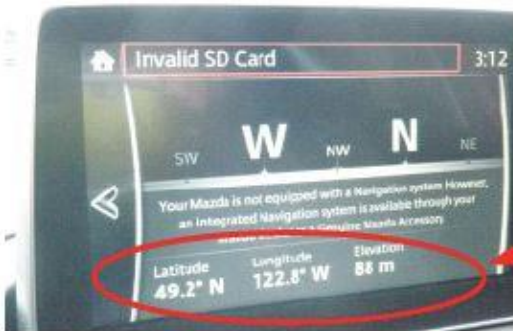
In the vehicle condition with no SD card being installed, turn the ignition ON and select the Navigation. If values for the latitude, longitude and elevation positions are displayed on the compass screen as shown in the figure, GPS reception is currently available.

If position values are displayed, it means GPS reception currently is available. If not available, (- - -) is displayed.

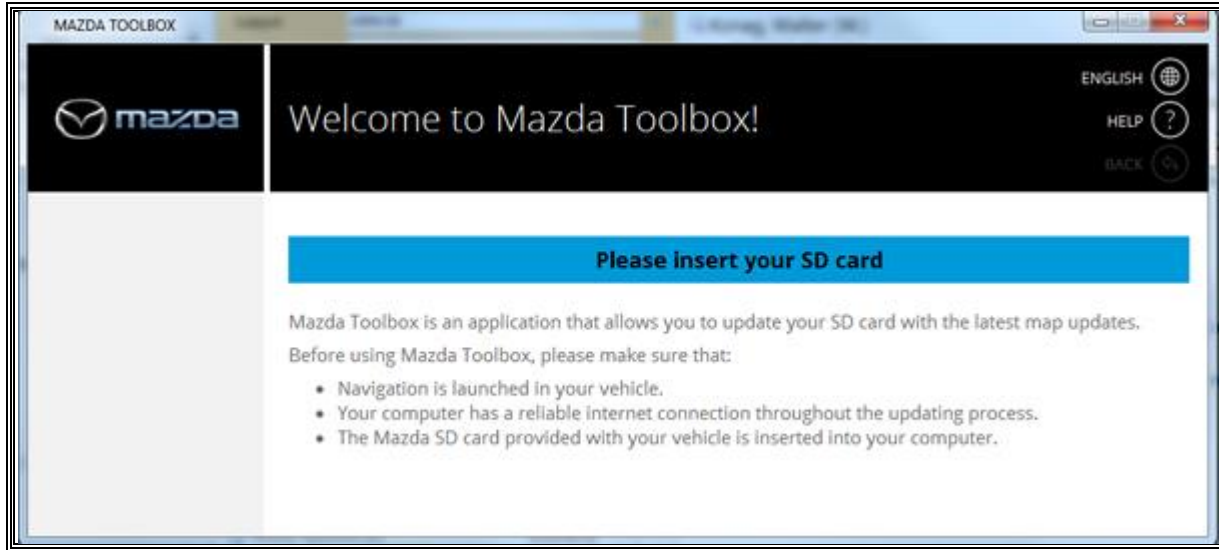
Compare if the VIN on the screen is same as the VIN of the concerned vehicle.

If these VINs do not match or the SD card has been locked to other vehicle and cannot be used on the concerned vehicle with error message "Invalid SD Card" on the center display.

**NOTE:** If MAZDA TOOLBOX is not able to read the SD card, replace the SD card with a new one\*.

In such a cases, there are two possibilities: (1) mixed-up with a SD card valid to another vehicle - Find the valid SD card for the concerned vehicle.

(2) SD card was mistakenly inserted to other vehicle and locked for that vehicle. - Replace the SD card with a new one\*\*\*.
