Technical Service Bulletin

POPPING AND/OR SQUEAKING NOISE FROM FRONT SHOCK ABSORBER AND/OR CREAKING NOISE FROM FRONT LOWER ARM BUSHING **Bulletin No.: 02-001/18**

Last Issued: 01/05/2018

2014-2016 Mazda3 vehicles (Japan built and Mexico built) with VINs starting with JM1 and 3MZ

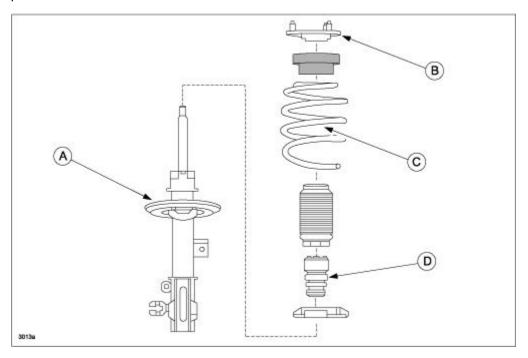
- A squeaking noise from the front shock absorber when turning the steering wheel at a vehicle standstill caused by stick-slip between the front strut bearing and the coil spring.
- A popping noise from the front shock absorber when passing over speed bumps caused by the bump stopper contacting the strut bearing when the shock absorber is compressed.
- A creaking noise from the lower arm when driving over road bumps at 20-40 km/h caused by stickslip of the front lower arm bushing. The noise occurs when the road surface is wet or after a car washing, and becomes more noticeable as the speed bump gets higher.

8. Replace the bump stopper with the modified one according to MGSS online instructions or the Workshop Manual (section 02-13 FRONT SHOCK ABSORBER AND COIL SPRING DISASSEMBLY/ASSEMBLY).

- Before removing the mounting rubber, mark its original position so it can be re-installed later to the same position.
- When replacing the bump stopper with a modified one, apply grease to upper side of the bump stopper and to the inside of the bump stopper (on the surface that contacts the damper rod).

CAUTION: It is not necessary to adjust the front wheel alignment because the front shock absorber and mounting rubber are not being replaced. However, make sure to install the mounting rubber to the original position.
