# Technical Service Bulletin

<b>Subject:</b>  Fctry or Factory MESSAGE DISPLAYED AFTER INSTRUMENT CLUSTER REPLACEMENT OR WHEN INSTALLING A ROOM FUSE IN A NEW VEHICLE	<b>Bulletin No.:</b> 09-002/18
	<b>Last Issued:</b> 01/09/2018

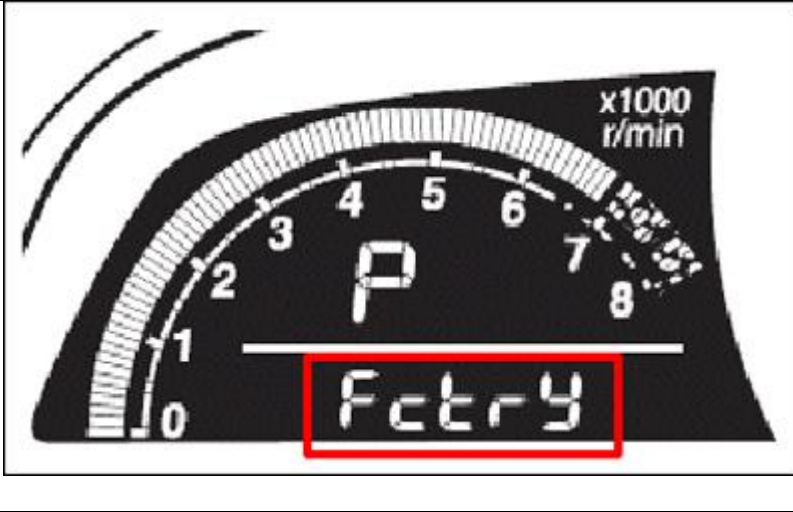
CX-3 shown:

After the installation of a new instrument cluster, the message "Fctry" or "Factory" is displayed instead of the odometer. This concern may also occur when a room fuse is installed in a new vehicle. Some new instrument clusters are in the factory mode setting. Factory mode cancellation is required.
